STAVEBNÍ OBZOR

ČÍSLO 4/2015

REHABILITATION OF HISTORIC HALF-TIMBERED WALLS WITH COMPOSITE MATERIALS BASED ON HIGH-STRENGTH

Tomáš Čejka¹, Klára Kroftová², Markéta Šmidtová³ and Radek Zigler⁴

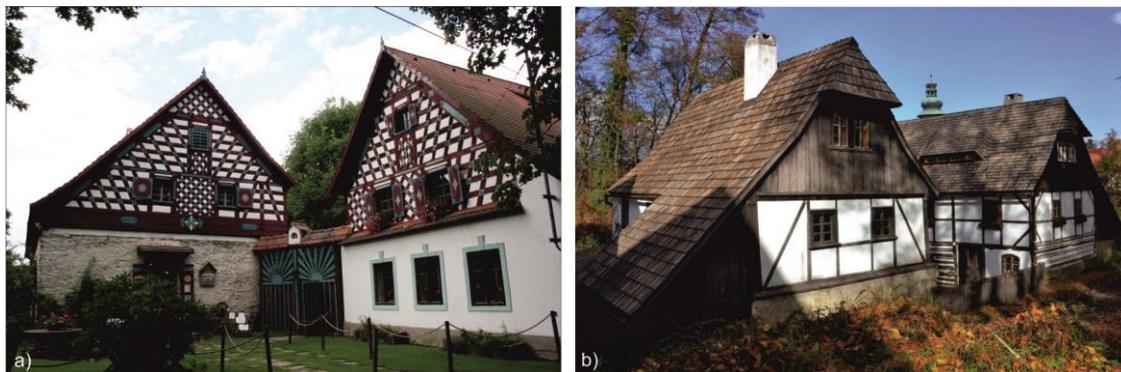
Fig. 1: Examples of half-timbered houses a) Doubrava; b) Kytlice

The origins of half-timbered buildings (Fig. 1a) most likely go back to the ancient world as evidenced e.g. by Vitruvius in his Ten Books on Architecture [1]. The origins of half-timbered and timber-framed buildings which were built in the Czech lands from the 14th to the late 19th century can be traced to Germany and Scandinavian countries, but also France, Switzerland and Austria. Numerous modifications and shape patterns of wooden elements of half-timbered walls are typical and expressive architectural and decorative elements of these buildings. The buildings preserved on the territory of the Czech Republic, mainly in the northwest border regions, largely represent houses with half-timbered constructions on the upper floor and in the gable and a timbered or masonry ground floor (Fig. 1b) [1].

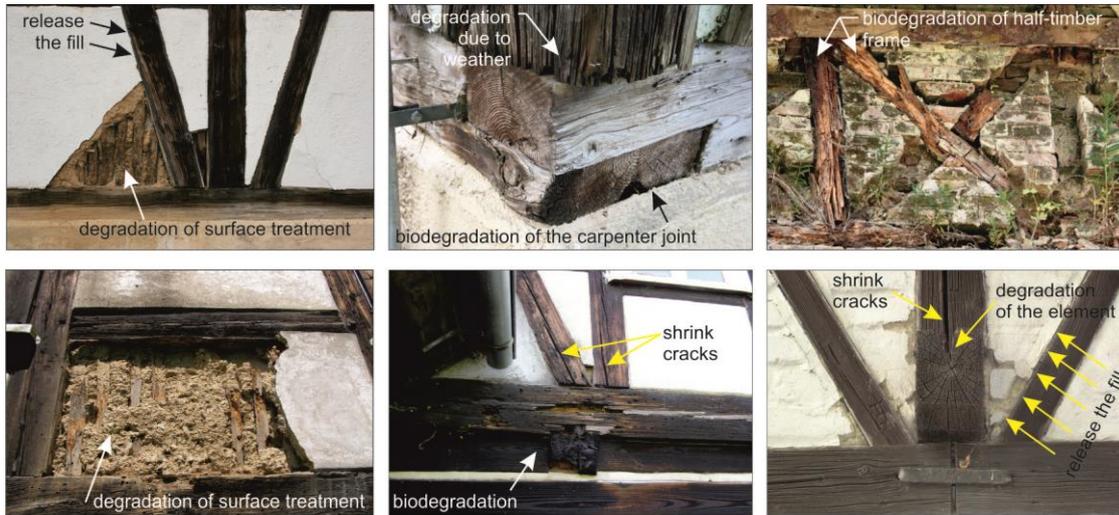
Fig. 2: Degradation of half-timbered houses

A preliminary construction and technical survey of selected historic half-timbered constructions showed that the most common defects of timber-framed constructions were insufficient thermal insulation properties of perimeter half-timbered walls, defects and poor quality of wooden elements, workmanship defects (faulty placement of the ground plate on the plinth, poor execution of carpentry joints of wooden elements, mounting wood with high moisture, mechanical degradation of wood, excessive shrinkage and creep of wood), inappropriately applied wood treatment, absorbent material of the plinth and a generally rigid connection between internal masonry constructions (masonry walls, partitions, chimney, etc.) disabling free pushing, strain or swelling and deformations due to loading by the timbered or half-timbered construction.

The survey revealed that the main causes of failures of half-timbered buildings were inadequate foundations (settlement and deformation of foundations), deformations and strain of the timber construction due to the shrinkage (or swelling) of wooden elements, insufficient rigidity and stability, roof truss deformations, loosening of joints of wooden elements and their degradation by wood-decay agents and rotting due to elevated moisture levels, high temperatures or aggressive environments, improper use and unqualified interventions. Fig. 3 shows examples of degraded carpentry joints and wooden elements of half-timbered constructions.

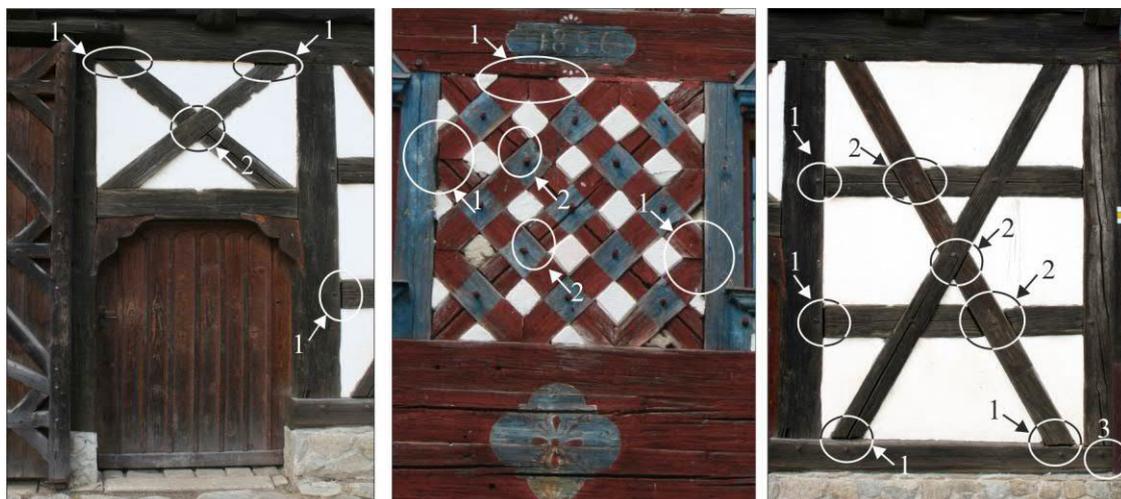
Fig. 3 Examples of failures (loosened connections) of different carpentry joints (legend 1 – tenon jointing (struts, noggins, posts), 2 – dapping (struts, noggin), 3 – halving (foundation plate))

The compression of the half-timbered frame due to wood shrinkage may reach values of up to several millimetres per meter of the wall height. This compression is prevented e.g. by the brick nogging, which, if properly wedged out, takes up part of the load transferred by the wooden frame. The loading of the joints of wooden elements due to this effect may cause the failure - loosening of connections of the half-timbered frame (Fig. 3). The joints thus created successively allow easy penetration of moisture accelerating the aging or rotting of wood.

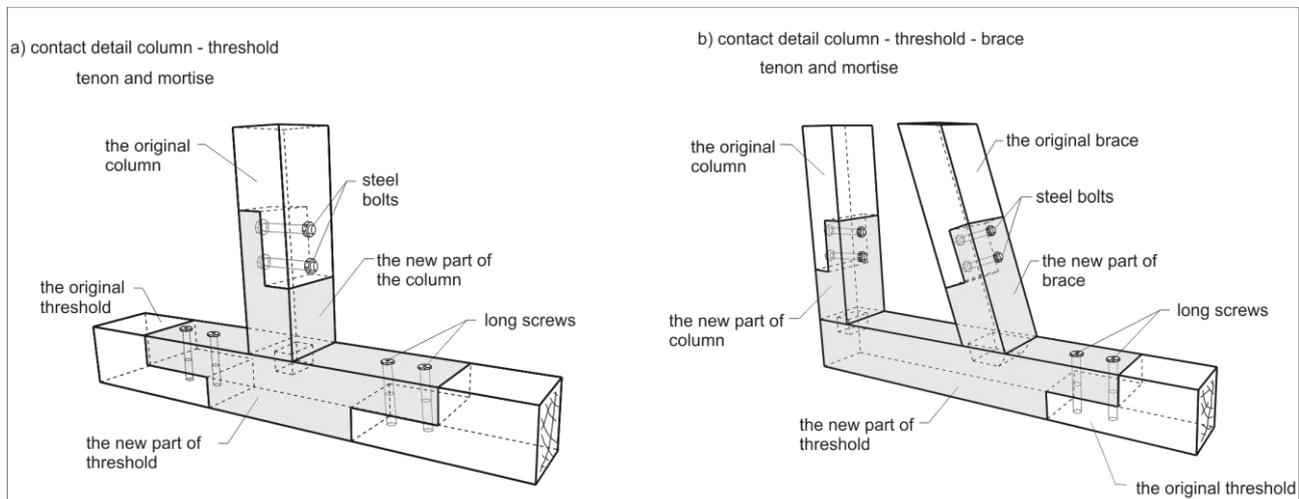
Loosened joints are currently wedged out during the rehabilitation or strengthened by means of suitably placed prostheses, stiffening elements, partial resin grouts, reinforcement (e.g. glass fibre connections, special steel bars), etc. Classic rehabilitation methods of timber members are used for the rehabilitation of parts of wooden or joint elements, e.g. placement of prostheses, replacement of parts of elements, etc. New and original parts of the construction are most frequently connected by carpentry joints, or joints complemented by steel bolts, pins, etc. (Fig. 4).

Fig. 4 Existing rehabilitation techniques of joints of elements

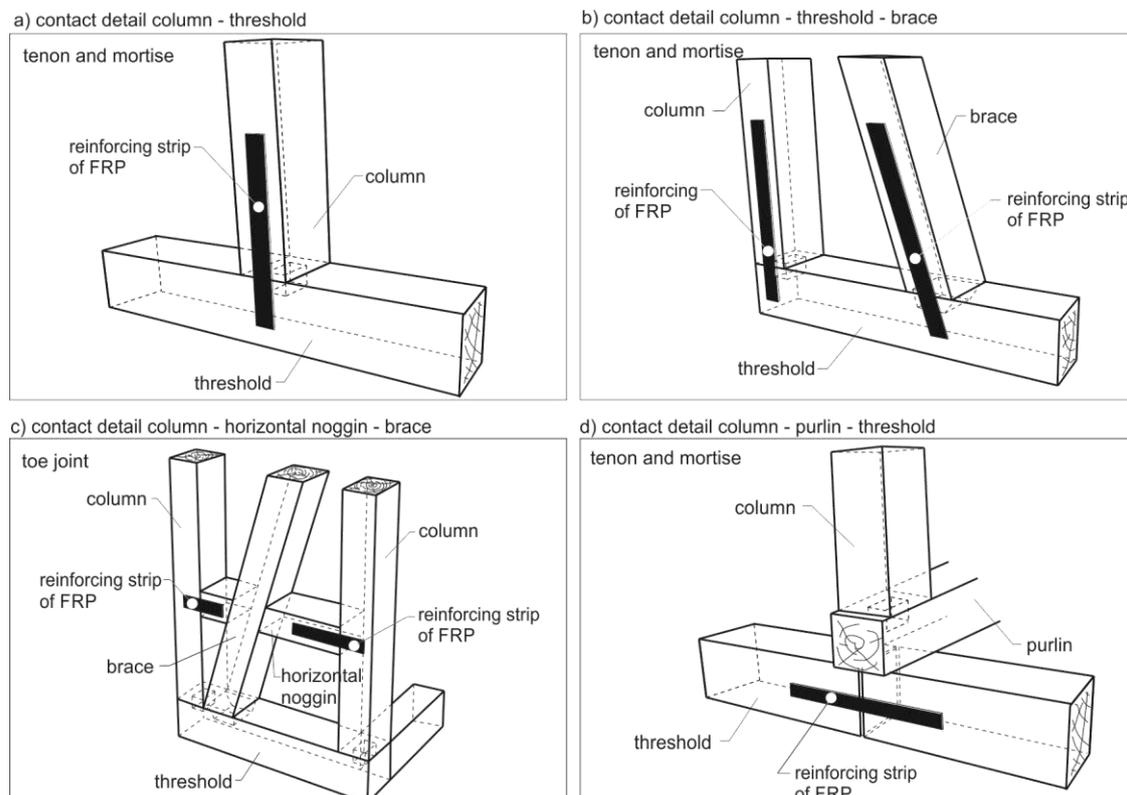
Fig. 5 Surface application of FRP fabrics for strengthening carpentry joints of half-timbered constructions

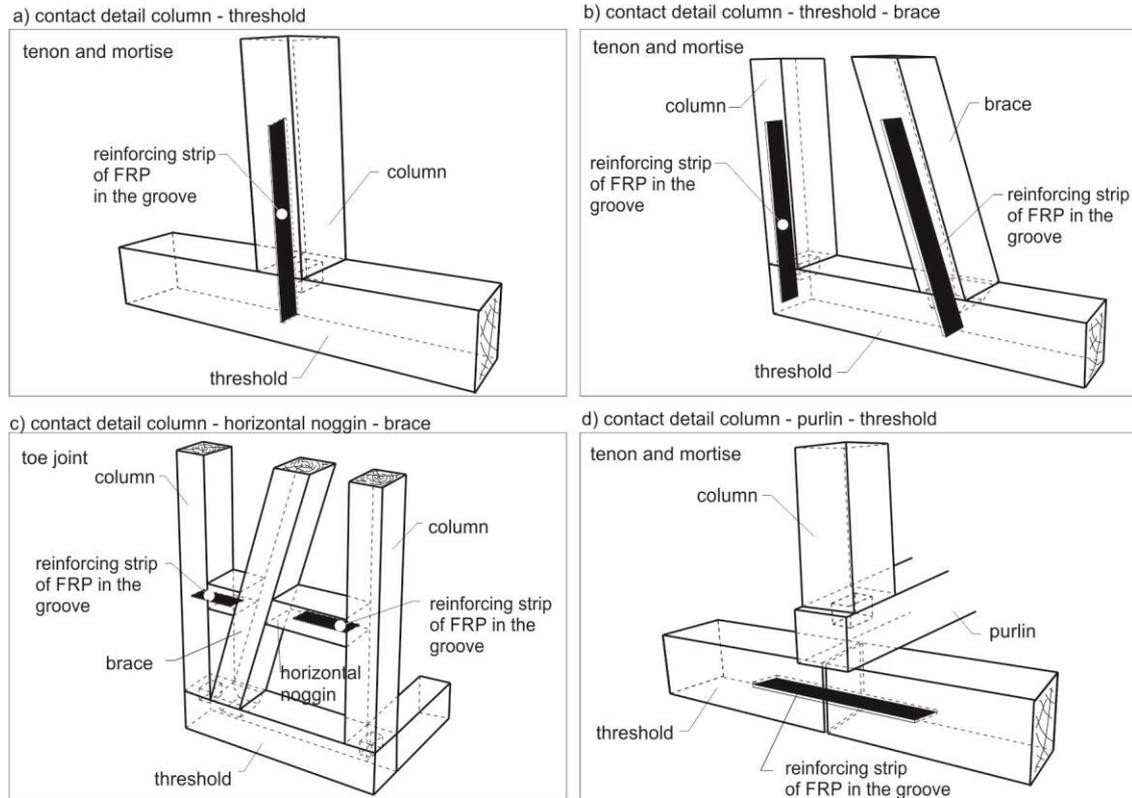
Fig. 6 Application of FRP fabrics in grooves for strengthening carpentry joints of half-timbered constructions

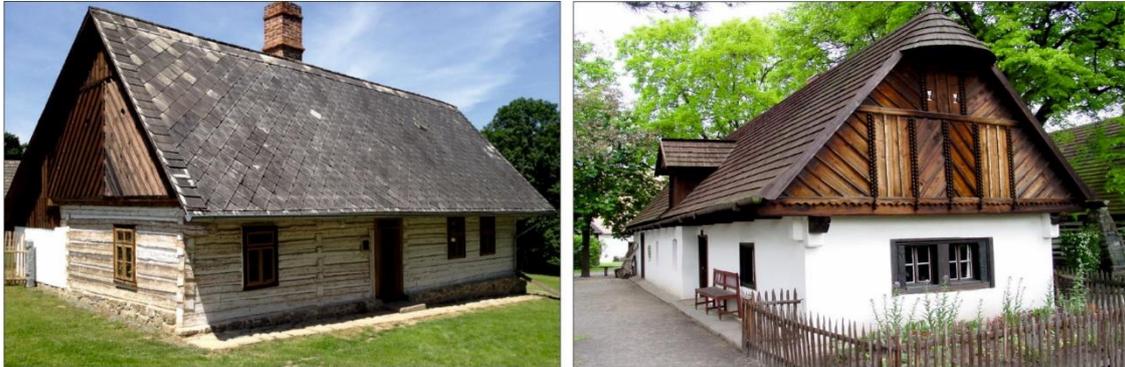
Fig. 1: Examples of timbered houses a) Příbram; b) Přerov nad Labem

The timbered constructions (Fig. 1), whose origins may be traced to mainly Central and Eastern Europe, were a widespread construction technology for residential and farm buildings used in our country from the Early Middle Ages. After the 12th century, timbered houses represented the predominant type of residential development on our territory, and their use in rural areas prevailed until the late 18th and the early 19th century, in northern and western Bohemia even until the late 19th century. The decline of building timbered constructions was primarily due to the prohibition of wooden constructions because of the risk and spread of fires in 1816. According to Schedel’s World Chronicle from the end of the 15th century, timbered framing was also found in urban buildings. There are timbered houses with a timbered wall construction on the ground floor and their upper floor construction is supported on the so-called pedestal formed by protruding columns and beams (ground plates) and constructions with a single living space resting on a masonry, mostly stonework, construction.

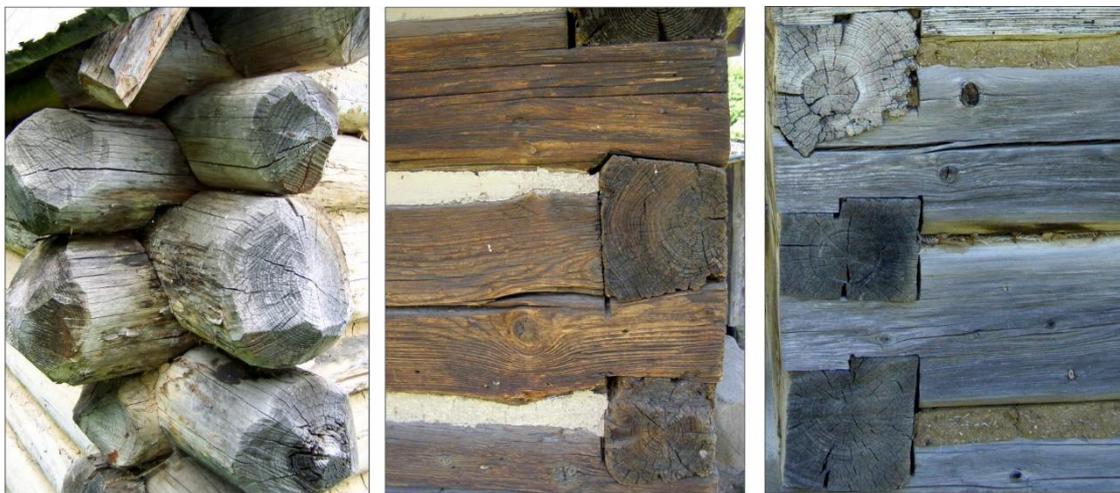
Timbered walls are usually made of horizontally mutually superposed solid logs or beams, most often joined in corners by the dovetail joint, or a dovetail joint with opposite inclined sides without overlaps to prevent the bond loosening and beam slippage; there may also be gaps between slabbed sections. From the late 18th century, the above bond was replaced by more demanding, so-called interlocks, with perpendicularly cut horizontal and vertical surfaces – mortises with perpendicular walls. Figs. 2a, 2b and 2c show examples of carpentry corner joints of timbered buildings. The gaps between horizontal wall elements were sealed with moss and subsequently puddled with clay, cob, reinforced with straw, animal hair, etc.

Fig. 2: Examples of carpentry corner joints of timbered houses

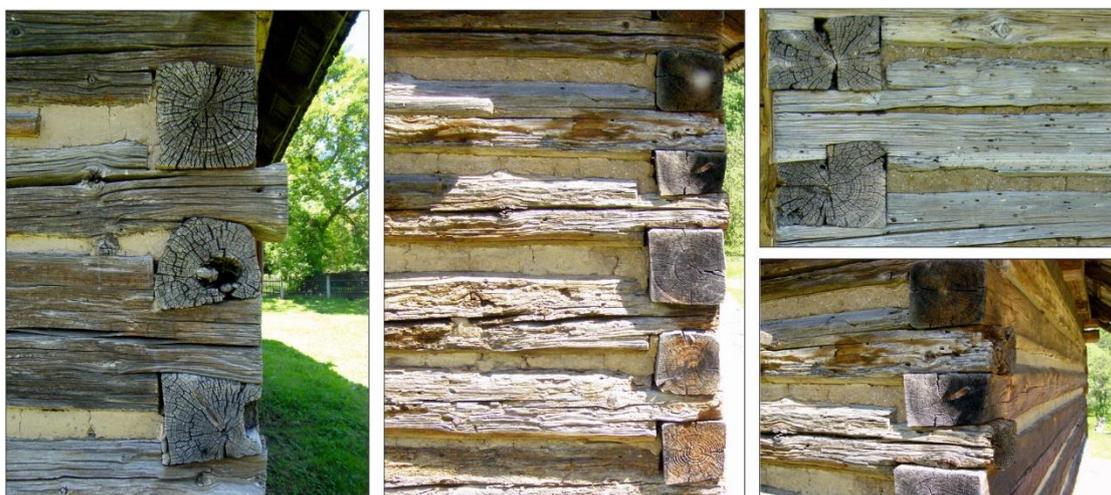
The most common defects of half-timbered and timbered constructions include insufficient thermal insulation properties of perimeter timbered walls, defects and poor quality of wooden elements, workmanship defects, faulty placement of ground plates on the plinth, poor execution of joints of wooden elements, mounting wood with high moisture levels, mechanical degradation of wood, mounting wooden elements with high moisture levels, excessive shrinkage and creep, inappropriately applied wood treatment, absorbent material of the plinth and a generally rigid connection between interior masonry constructions (Fig. 3).

Fig. 3: Degradation of timbered houses

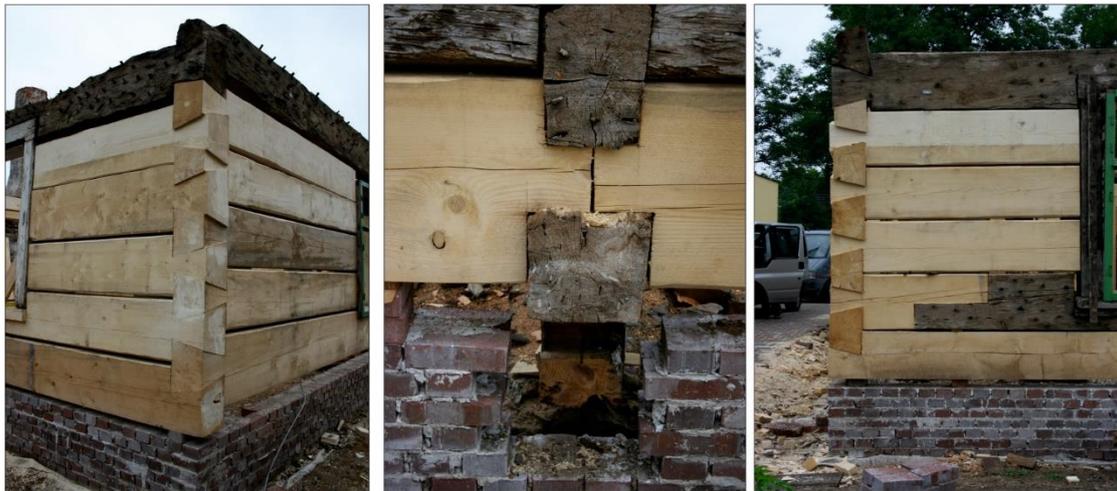
In the construction and technical perspective, the rehabilitation of damaged structural members and joints may be carried out as follows. Loosened connections must be wedged out or strengthened with suitably placed prostheses, stiffening elements, partial resin grouts, reinforcement (e.g. glass fibre connections, special steel bars), etc. (Fig. 4).

Fig. 4: Rehabilitation of elements and joints of timbered wall using the classic method – replacement, sealing

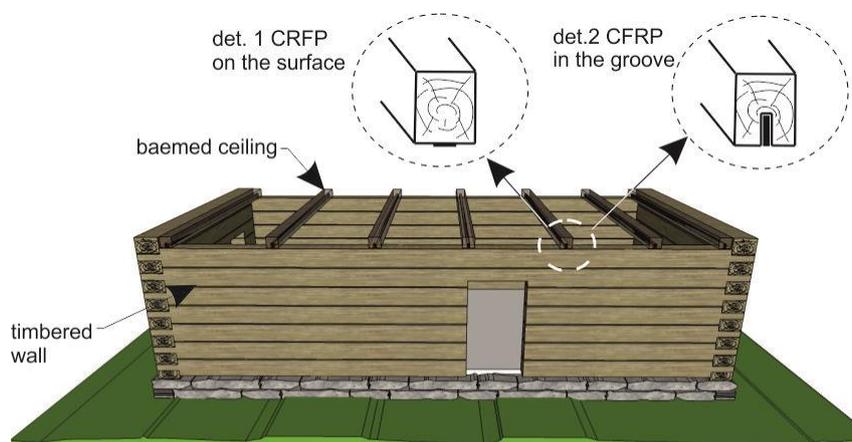
Fig. 5: Securing the spatial rigidity of a timbered construction in the case of degraded tie beams – reinforcing FRP strips or lamellae are led along the surface or in the groove of joists and anchored to the outside

surface of timbered walls

In the case of vertical structures, the use of prestressing or non-prestressed composite strips based on high-strength fibres and epoxy resin is preferred to capture the horizontal forces exerted by the roof truss to avoid the tilting of timbered walls - opening up of the building - and the slippage of the upper beams of the wall. It is advisable to place these strips on the surface of joists (Fig. 5) and anchor them to the outer wall surface. The composite strips placed in this way increase the rigidity of the building and may partly replace transverse (interior) timbered walls securing the spatial stability and rigidity of the construction.

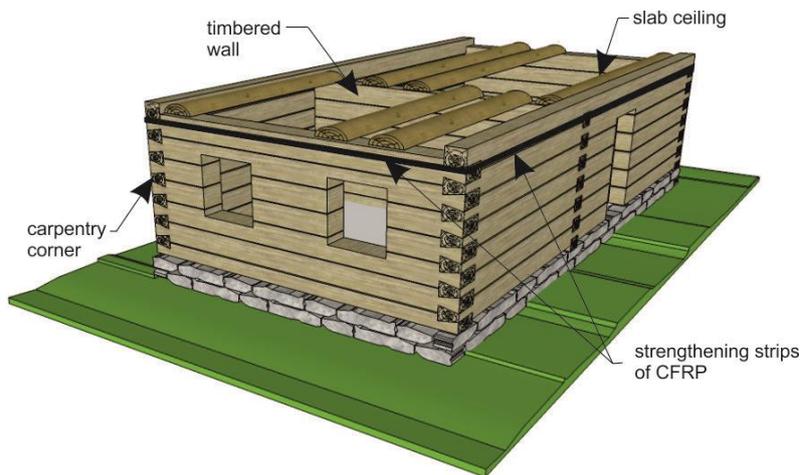
Fig. 6: Securing the spatial rigidity of a timbered construction by a reinforcing collar beam at the floor construction level

In the case of a multi-storey timbered building, like in a masonry building, adding a “reinforcing collar beam” at the floor construction level over the 1st overground storey using prestressing lamellae may be an effective solution (Fig.6).

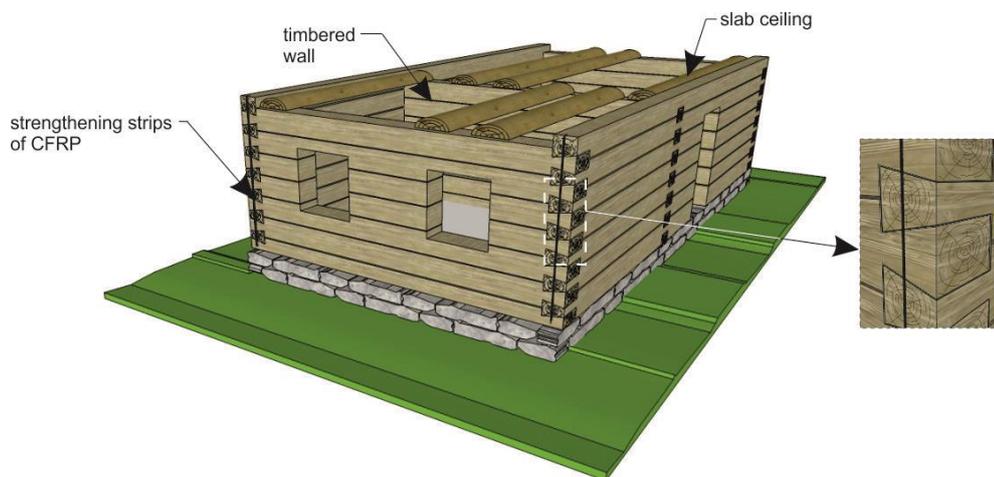
Fig. 7: Vertical stiffening of beam joints – limitation of the slippage of wall elements from joints, enhanced resistance of the timbered construction to seismic effects

Vertical bracing or prestressing of joints of horizontal members (corners of the building) with composite strips based on high-strength fibres and epoxy resins limits the potential slippage of individual members from the joint in the case of degraded dovetail joint surfaces. It is advisable to place vertical stiffening strips or lamellae in the vertical groove to ensure the functionality of the joint reinforcement increasing, at the same time, the fire resistance of the remediation measure. This remediation method requires the adjustment of the anchoring surfaces of wooden elements so that they are cohesive, planar, without increased moisture contents (Fig. 7).

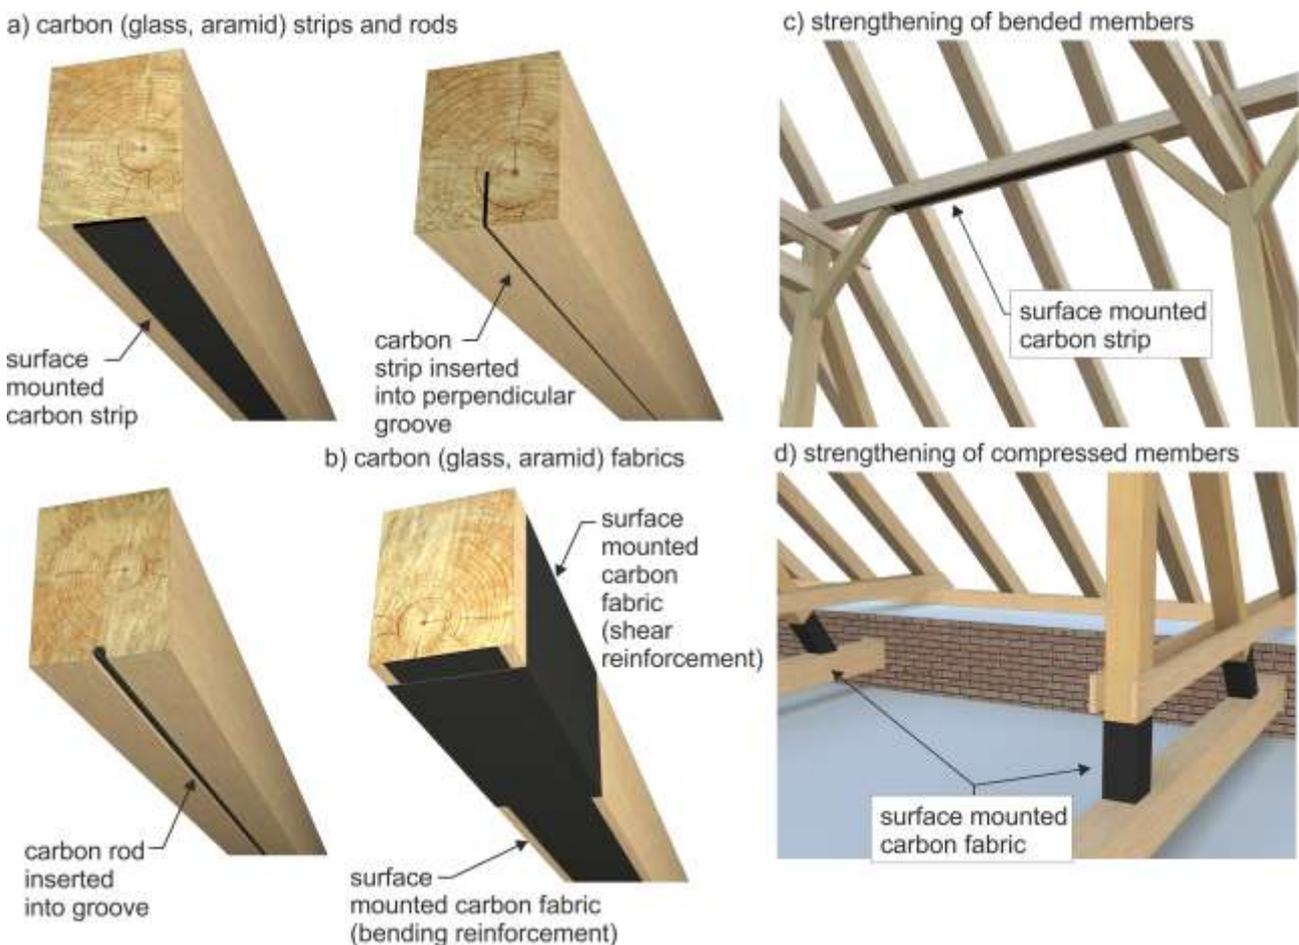
Fig. 1 Examples of strengthening of timber structures using externally bonded FRP materials (EBR)

For strengthening of timber elements stressed mainly by bending or shear, FRP materials (in the form of lamellas, rods, or fabrics) placed on the surface of strengthened element (Externally Bonded Reinforcement - EBR) or in the grooves near the surface (Near Surface Mounted - NSM) are used. FRP materials can also be used to stabilize or strengthen joints of the wooden elements. Fig. 1 shows some examples of possible strengthening interventions for timber load bearing elements and Fig. 2 shows examples of the possible joint stabilization or strengthening. In all cases, it is vital that the adhesive used for the bonding of wood in structural applications should be characterised by high shear strength and good compatibility with different kinds of wood types [2].

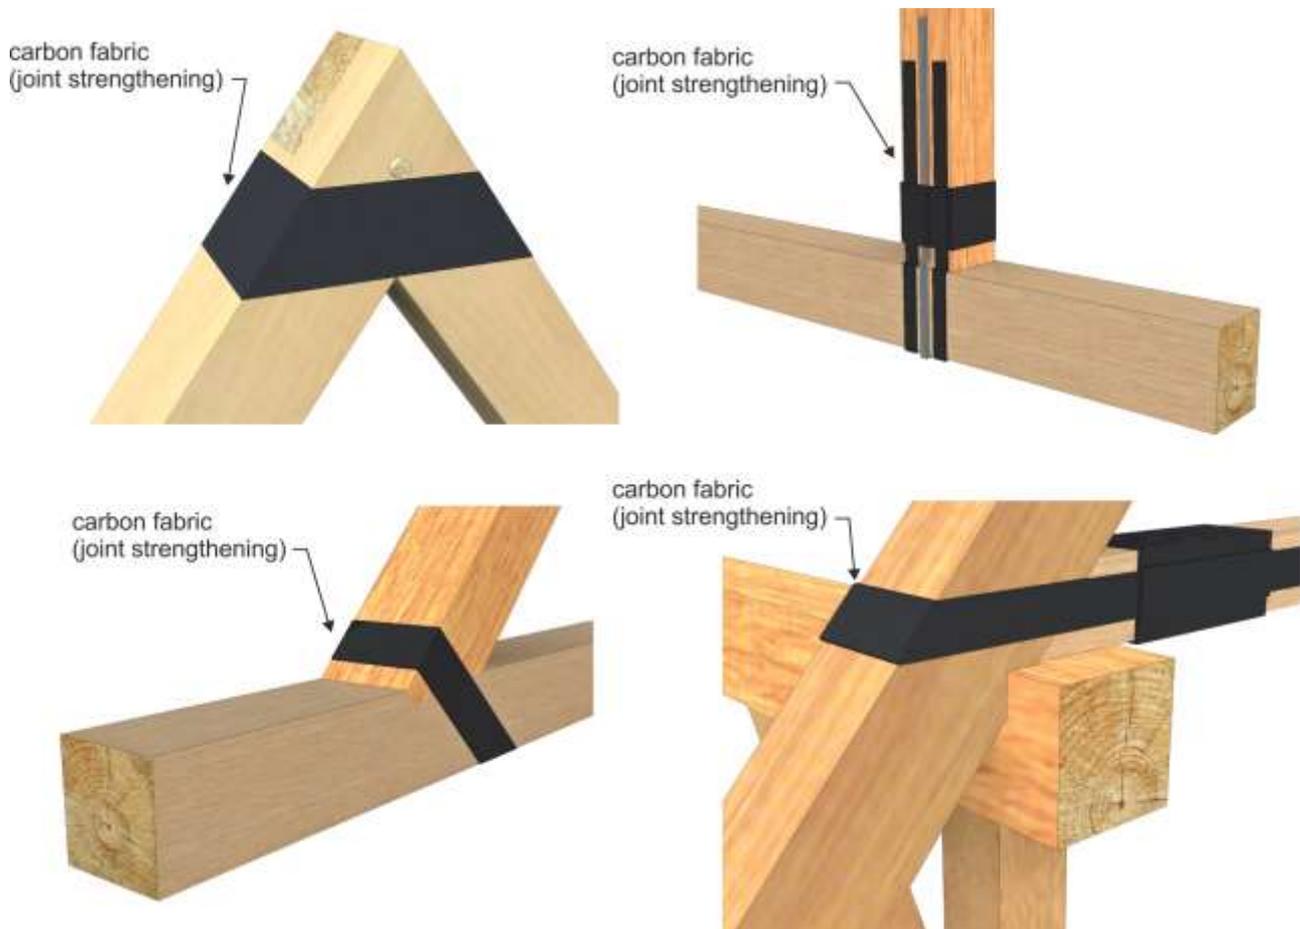
Fig. 2 Examples of possible joint stabilization and strengthening using externally bonded FRP materials (EBR)

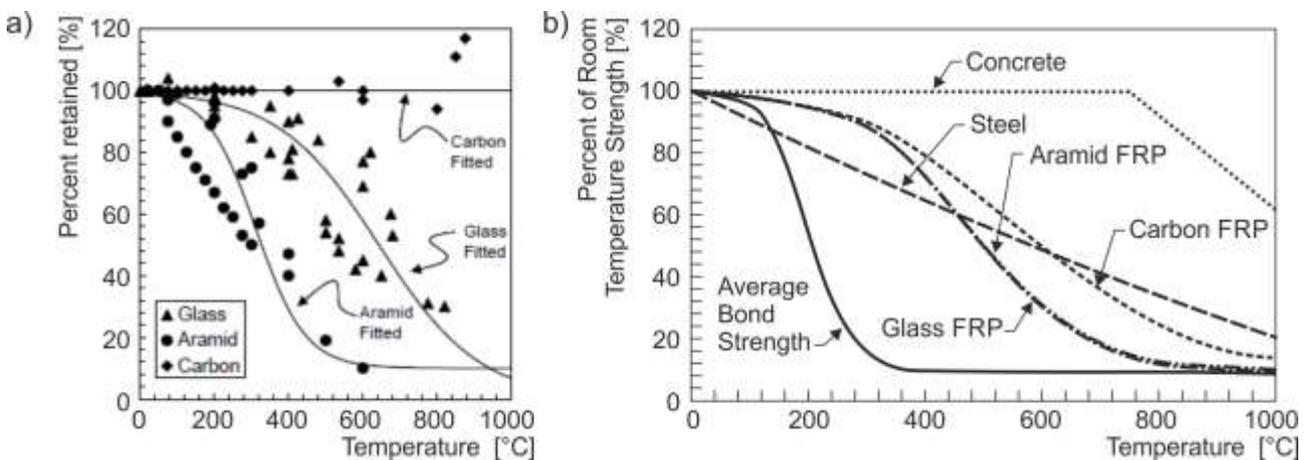
Fig. 3. Approximate variation in tensile strength and bond strength with temperature increase; a) Bare fiber strength [10]; b) FRP, concrete and reinforcing steel [11]

One of the characteristics of FRPs is their low glass transition temperature (T_g). T_g is the midpoint of the range of temperatures over which the FRP polymer matrix undergoes a change from hard and brittle to viscous and rubbery. Polymer matrices that cure at room temperature and are often used for structural strengthening have glass transition temperatures T_g ranging from 60°C to 130°C. At temperatures above 400 °C, FRPs are susceptible to combustion of polymer matrix and can even evaporate [9]. Without protection from heat, a polymer matrix may also ignite, emit smoke, and support spreading of flame. When exposed to fire, FRP materials may suffer charring, melting, delamination, cracking and deformation. Figure 3 shows that for some types of matrices, debonding can be well advanced at 200°C. It also shows that the fibers themselves lose strength with rising temperatures, with carbon fiber losing the least.

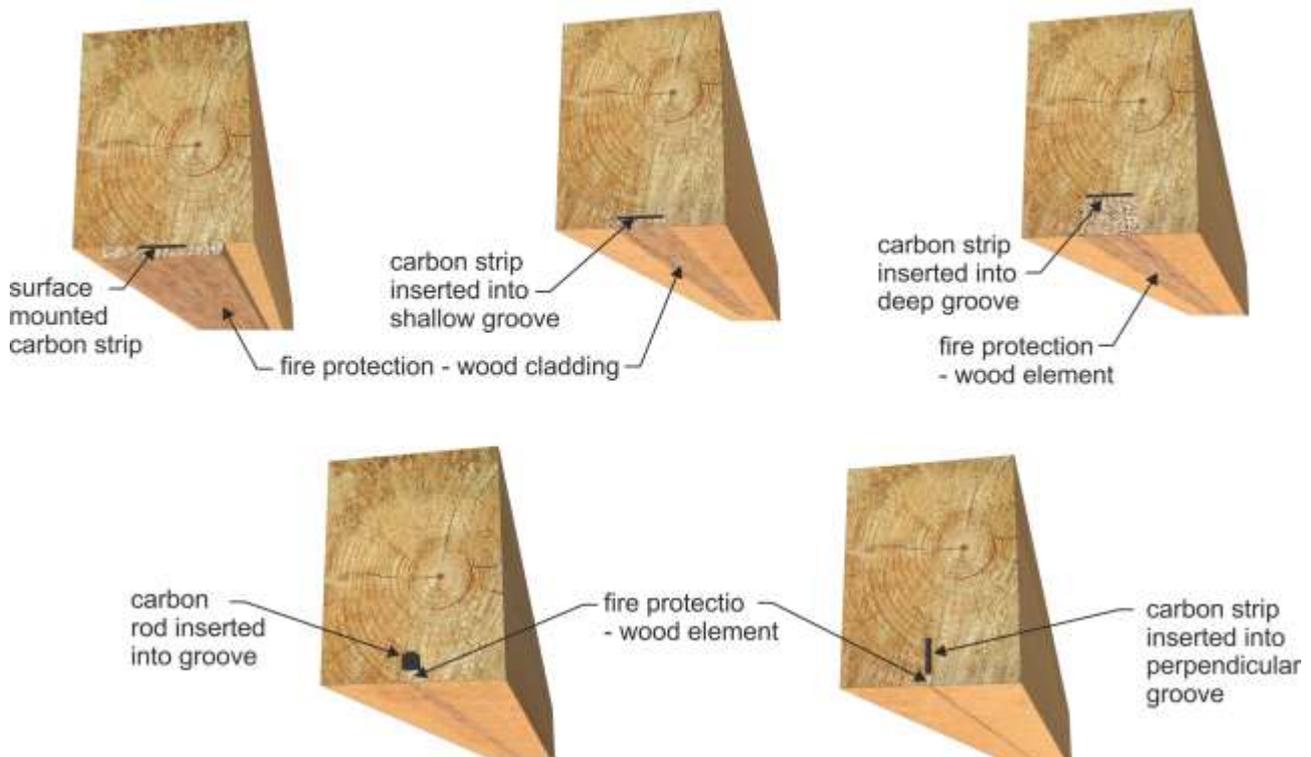
Fig. 4 Fire protection of strengthening FRP elements

On the other hand the use of fire protective cladding based on wood elements with sufficient thickness can be applied to protect the FRP strengthened elements. The use of wood cladding appears to be the best option in particular for timber elements reinforced with FRP materials inserted into grooves (NSM). In this case the wooden cladding fulfills both the fire protective and aesthetic functions (Fig. 4).

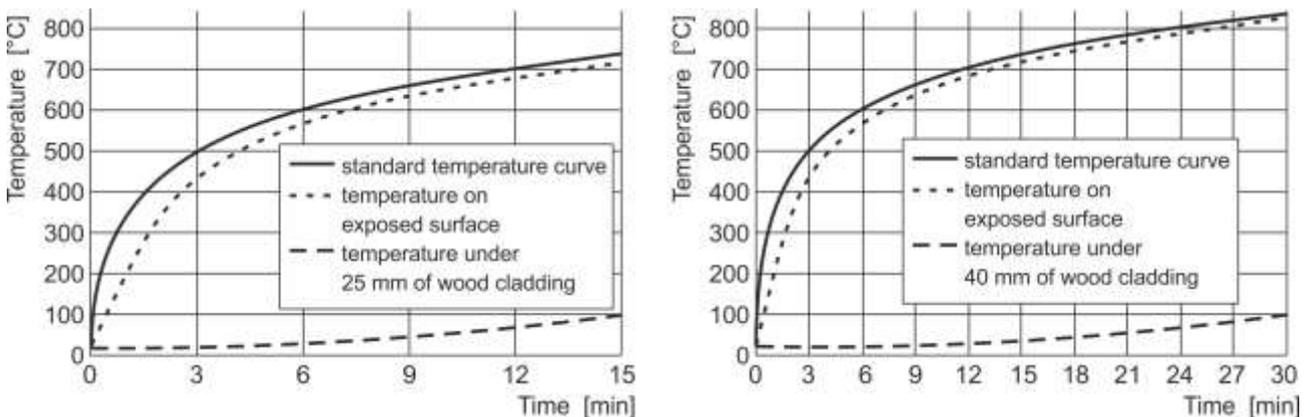
Fig. 5 Temperatures at the FRP reinforcement in case of fire protection system using wood cladding 25 mm (left) and 40 mm (right) thick

The parametric study results show that the wooden cladding with thickness of 25 mm under the conditions of standard fire can provide a critical temperature of the FRP below 100 °C for a maximum period of about 15 minutes (Fig. 5, left). If the cladding thickness is increased to 40 mm, fire protection for about 30 minutes (Fig. 5, right) can be achieved.

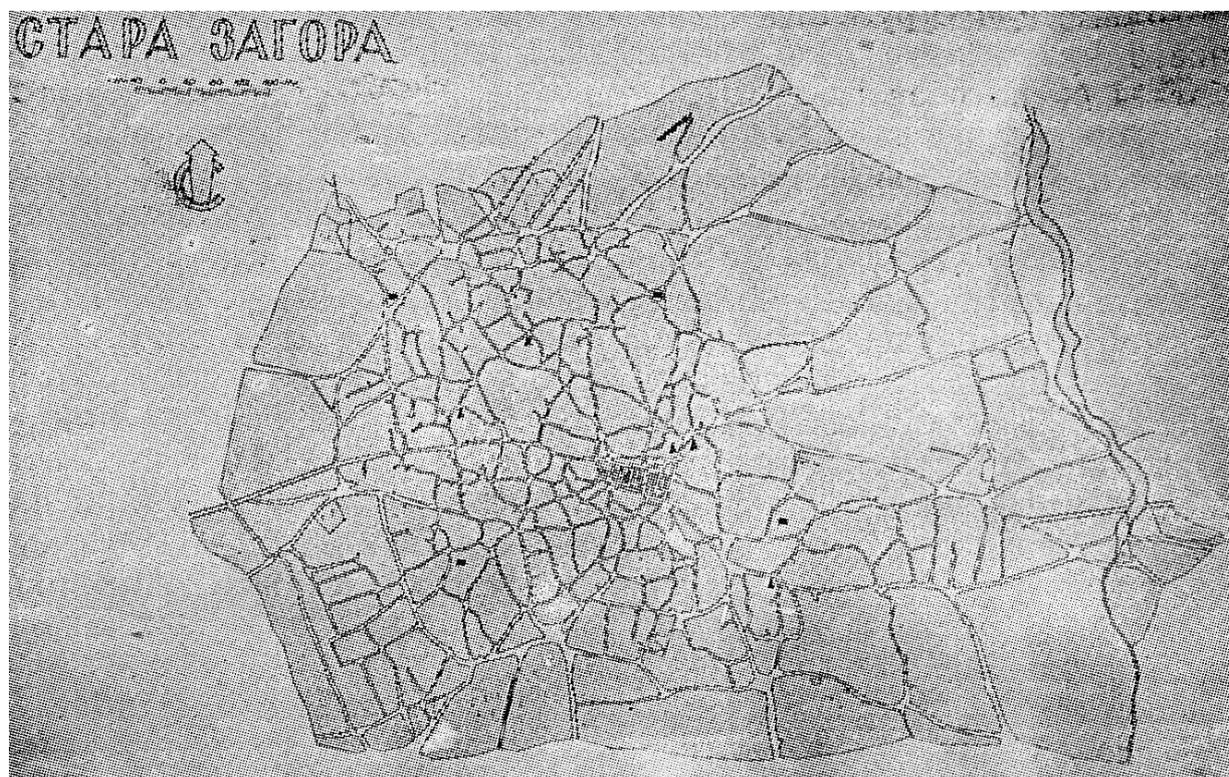
Fig. 2: Original structure of the city of Stara Zagora before the war 1877-1878. Source [2]

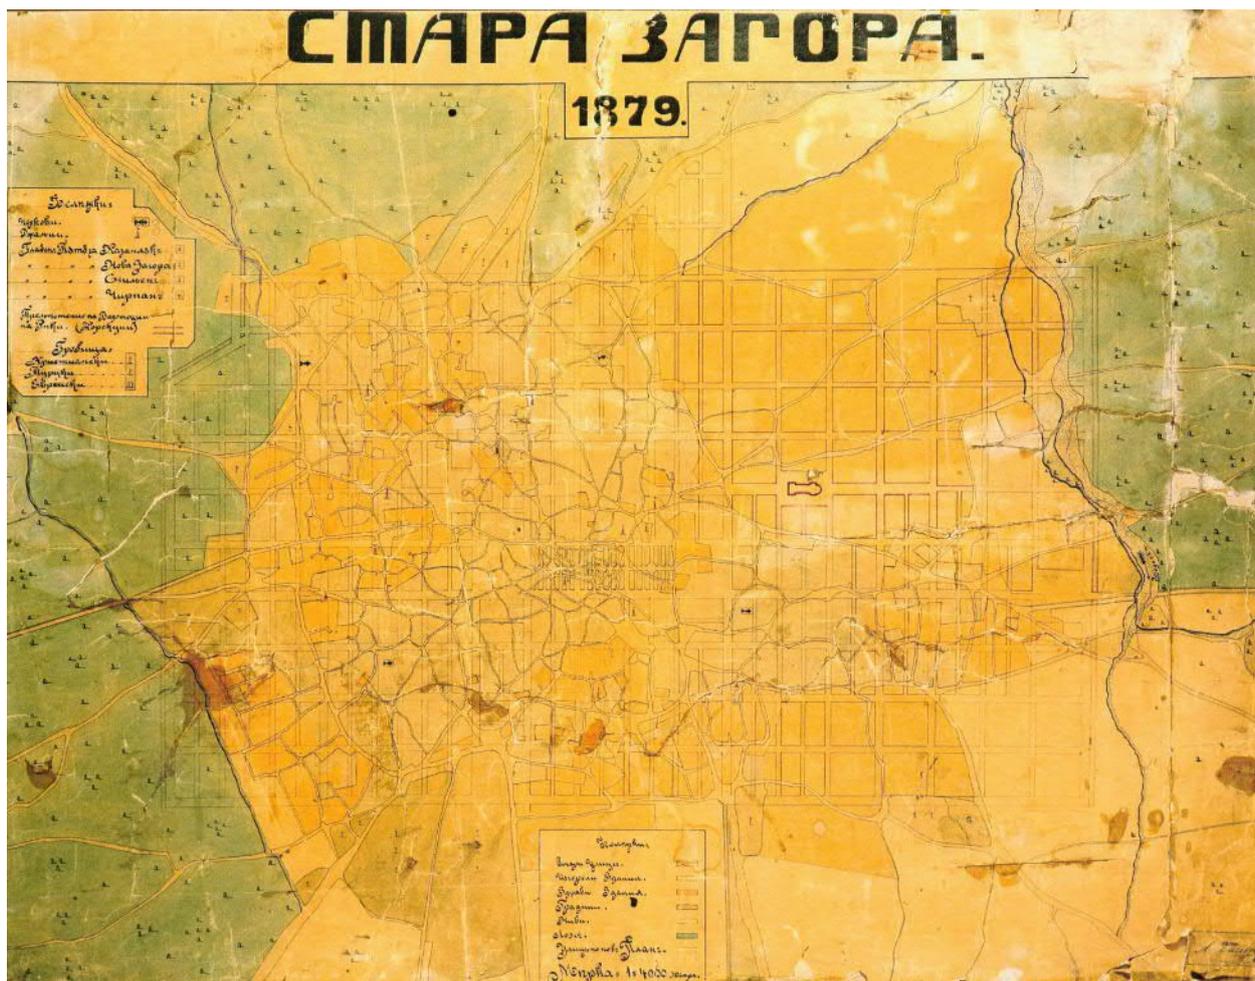
Fig. 3: Regulatory plan of the city of Stara Zagora by Libor Bayer, 1879.
Source: Regional Historical Museum in Stara Zagora

In April 1879 Libor Bayer arrived with his family to Stara Zagora and he started working on the city plan immediately. Because of the housing crisis there was no time to do any detailed research on the earlier situation of the city and in May the plan was finished. Bayer applied a freely orthogonal geometrical network that did not take into account the old streets and buildings. On 21th of May 1879 the municipality accepted the plan and it was sent to the Directory of public buildings of Eastern Rumelia to be approved. Before approving the director Georgi Valkovich sent the main architect of Eastern Rumelia, the Italian Pietro Montani, to Stara Zagora to check the plan properly in situ. On 2th August 1879 the plan was approved by Montani and then also by the general-gubernator of Estern Rumelia Alexander Bogoridi by decree No. 194 from 27th August 1879. The final plan was finished in scale of 1:4000 (Fig. 3). After a month on 23th September 1879 the basic stone of the new city with memorable plate for future generations was laid down by Alexander Bogoridi. So at last in 1879 the construction of new houses began and in the end of the year there were about 310 new houses. The beginning was very difficult and there were a lot of people without housing and a lot of complainers. But in some time the plan was realized and the city of Stara Zagora turned into a modern European city. [7] [8] [9] [10] [11]

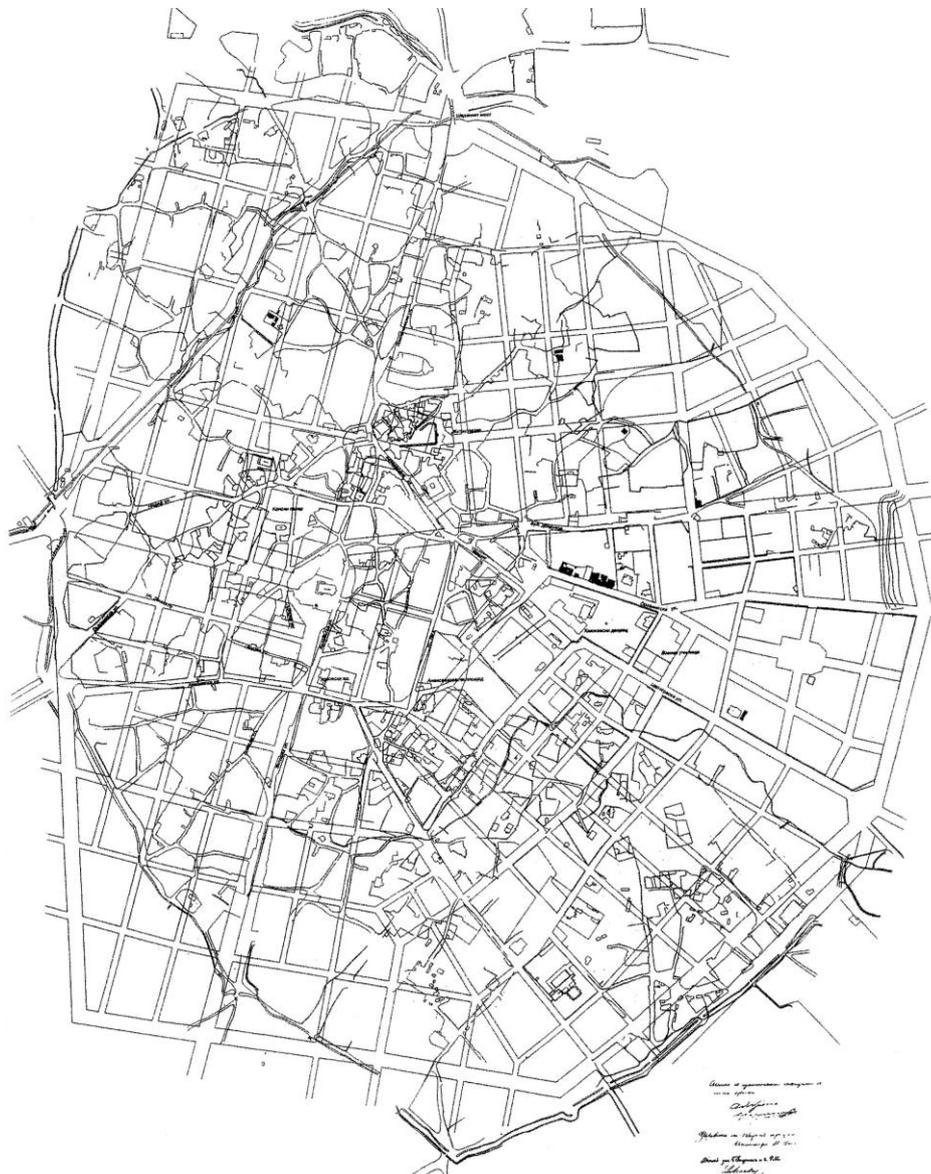
Fig. 6: Detailed (combined) Kopytkin's plan of the city of Sofia, 1881.
Source: Zheleva-Martins D., 2006 Biografiya na Sofiya

From April 1880 Kopytkin and probably also a city architect Licurgo Amadey and his deputy Václav Roubal worked on a cadastral plan of the city of Sofia (till 1881). This cadastral plan was approved on 2th June 1881. At the end a detailed plan combining the Kopytkin's regulatory and cadastral plan was worked out. All the three plans – regulatory, cadastral and detailed (Fig. 6) were approved together on 3th September 1881. The realisation of the plan was going on to the first half of 1890s. [13] [14]

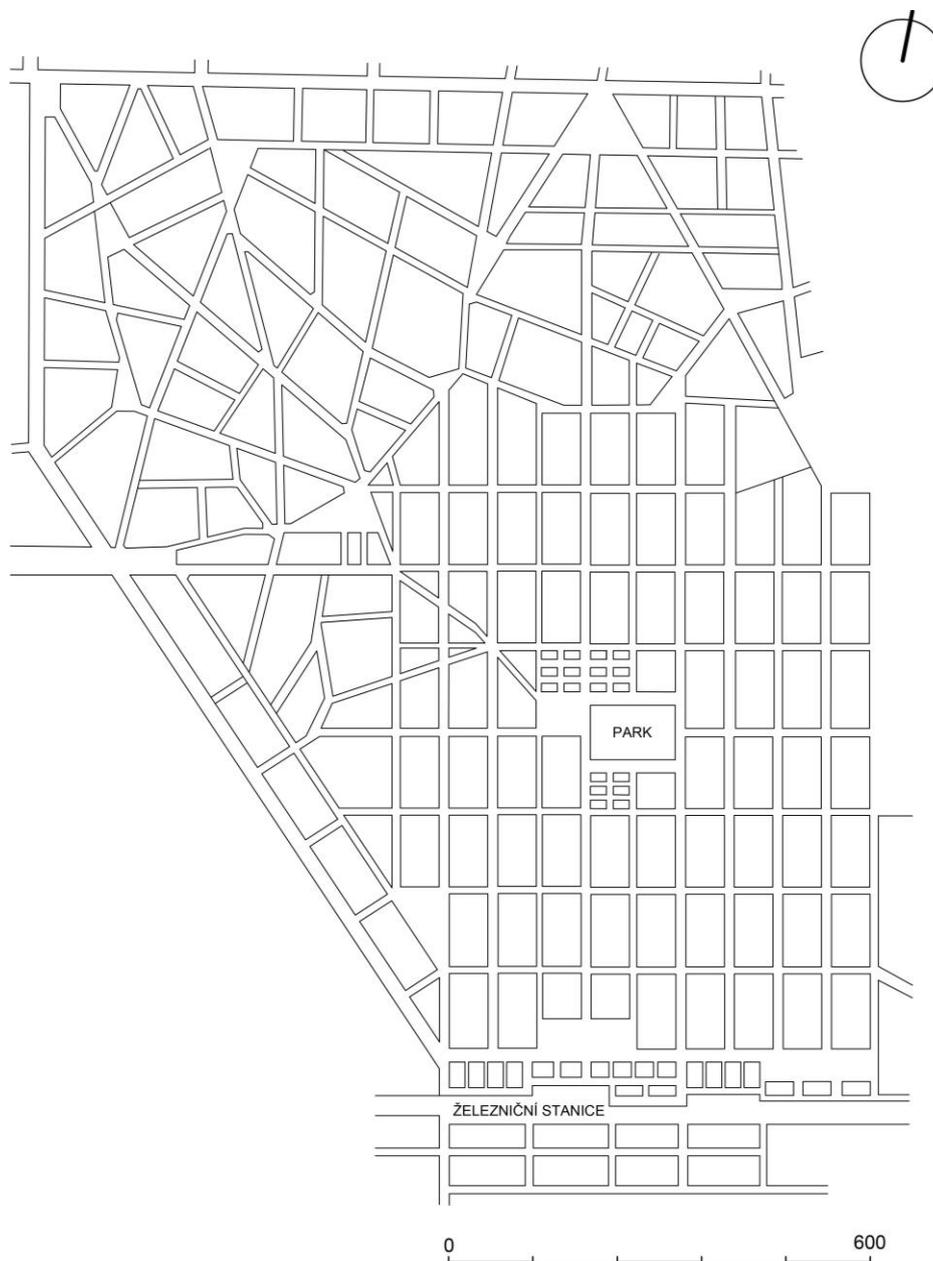
Fig. 7: Libor Bayer's regulatory plan of the city of Nova Zagora, 1881. Source: author

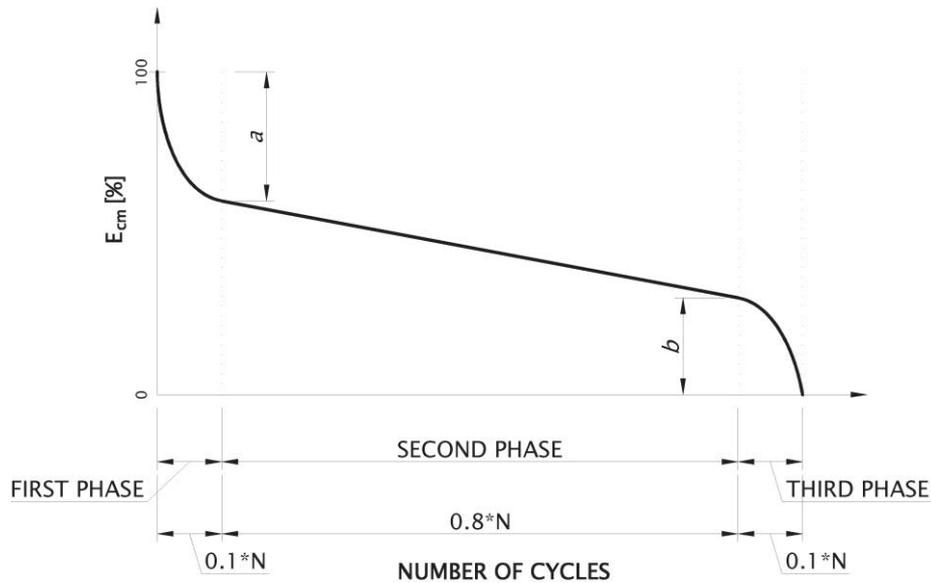
Fig. 1: Development of the secant modulus of elasticity of concrete under cyclic loading [4]

The development of the secant modulus of elasticity under cyclic loading reflects the development of strain or deformation, and vice-versa. The development of the secant modulus of elasticity under cyclic loading was described by Holmen in 1979 [4], see Fig. 1.

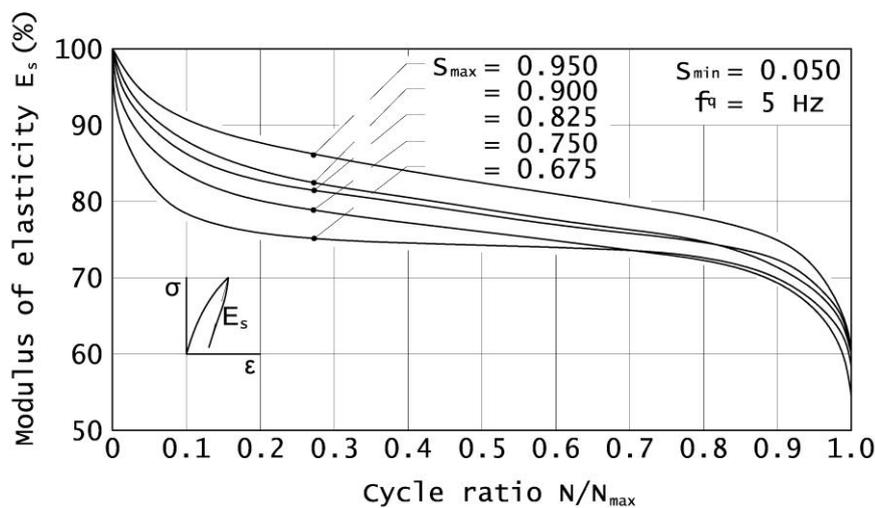
Fig. 2: Percentage reduction of the secant modulus of elasticity with the cycle ratio. Mean curves for different stress levels (from [4])

In his research, Holmen used a loading frequency of 5Hz and minimum stress equal to $0.05f_{cm}$. The maximum stress varied from $0.675f_{cm}$ to $0.95f_{cm}$. The first phase of development of the secant modulus of elasticity finished at 75-95% of E_{cm} , and the second phase finished at 68-75% of E_{cm} , depending on the maximum stress applied, see Fig. 2.

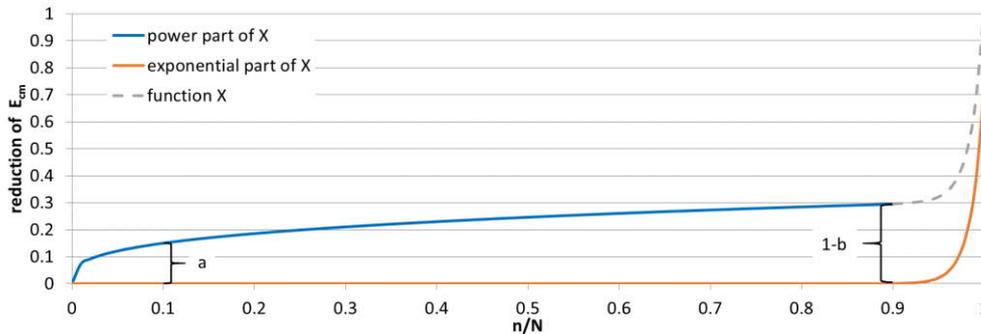
Fig. 3: Example of the power and exponential part of function X

- Its value for $n/N = 0.0$ to 0.9 has to be insignificant.
- Its value for $n/N = 0.9$ to 1 has to be dominant.
- Its value at $n/N = 1$ has to be equal to b , so that the sum of the power and exponential part is equal to 1. The exponential part has behaviour as in Fig. 3.

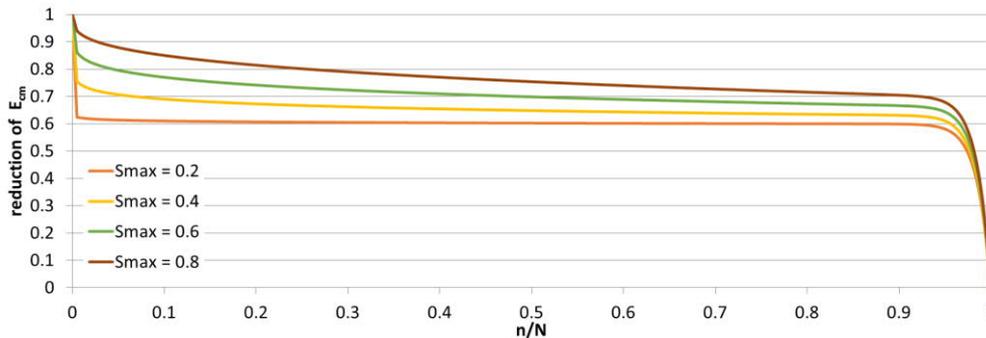
Fig. 4: Example of the fatigue damage function for various load levels

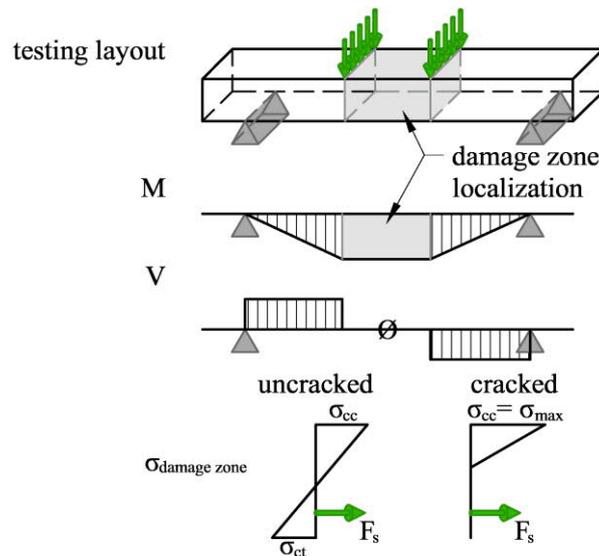
Fig. 5: Four-point bending arrangement and localization zone principle with the stress distribution in the damage zone

The four-point bending tests were chosen for their advantage of zone subjected to pure bending (decomposed to pure compression/tension) without the influence of shear. This material point zone, i.e. the crack localization zone corresponds to the behaviour of common structures. The principle described above and the stress distribution on an ideal cross-section is illustrated in Fig. 5.
