STAVEBNÍ OBZOR

ČÍSLO 4/2015

REHABILITATION OF HISTORIC HALF-TIMBERED WALLS WITH COMPOSITE MATERIALS BASED ON HIGH-STRENGTH

Tomáš Čejka¹, Klára Kroftová², Markéta Šmidtová³ and Radek Zigler⁴

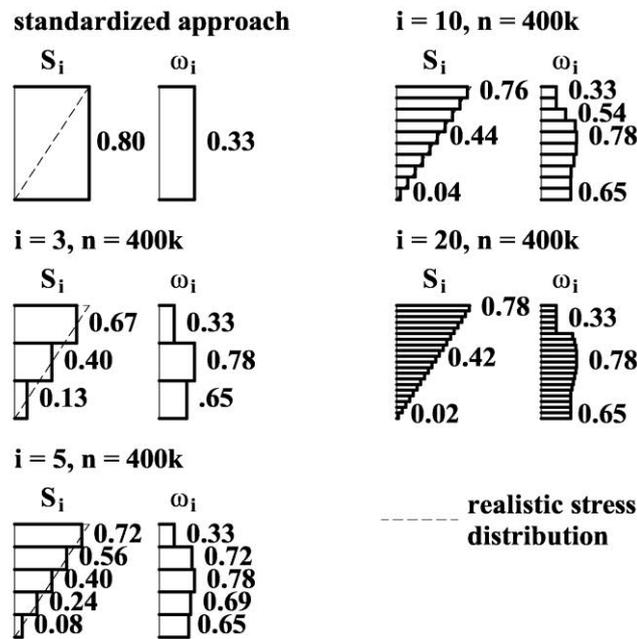
Fig. 6: Principle of partial integration of the compressive zone with the results of sensitive analysis for $n = 400,000$ cycles

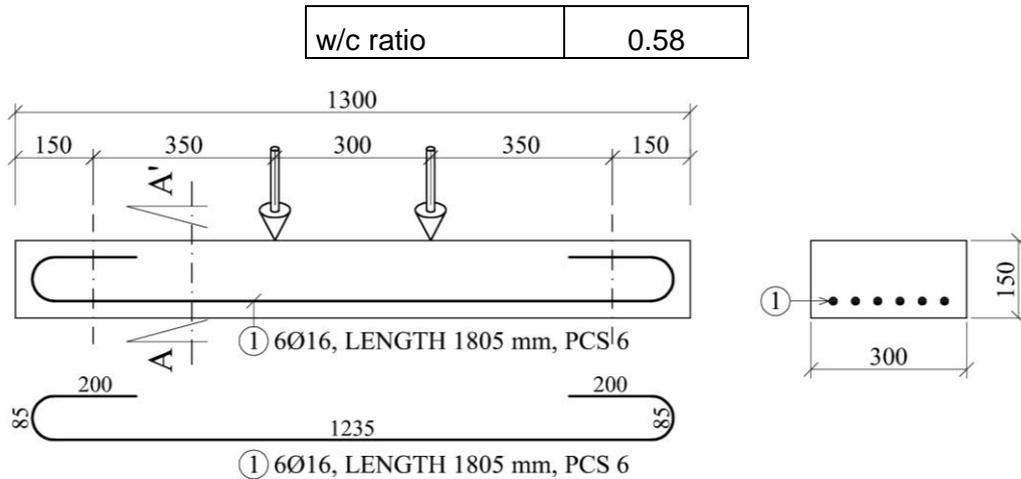
Fig. 7: Scheme of the fatigue testing specimen and its reinforcement

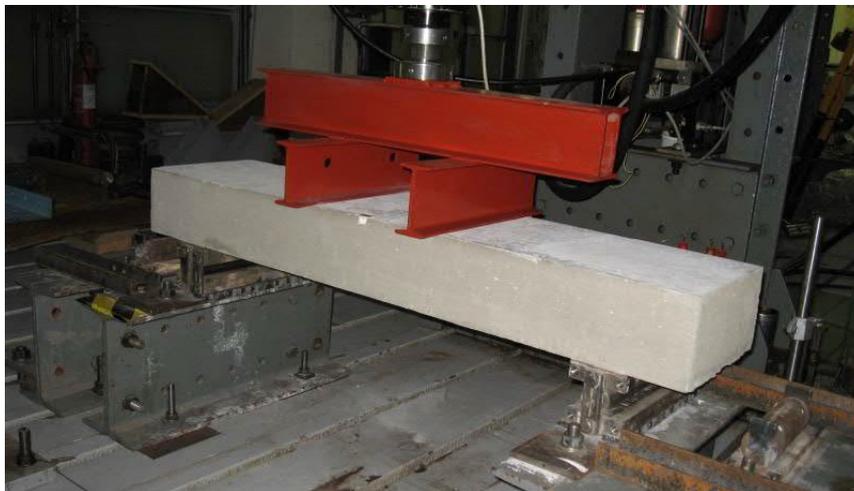
Fig. 8: Arrangement of the fatigue testing

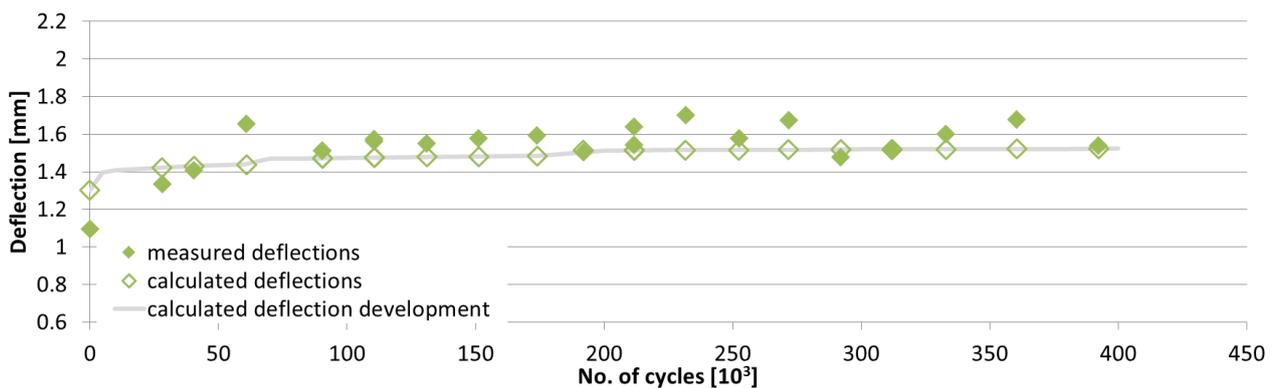
Fig. 9: Comparison of measured and calculated deflections for set #1

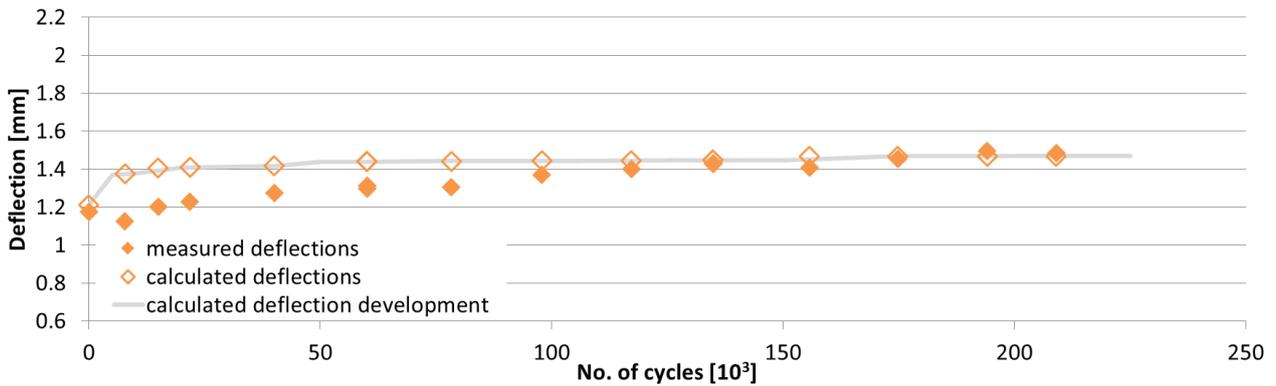
Fig. 10: Comparison of measured and calculated deflections for set #2

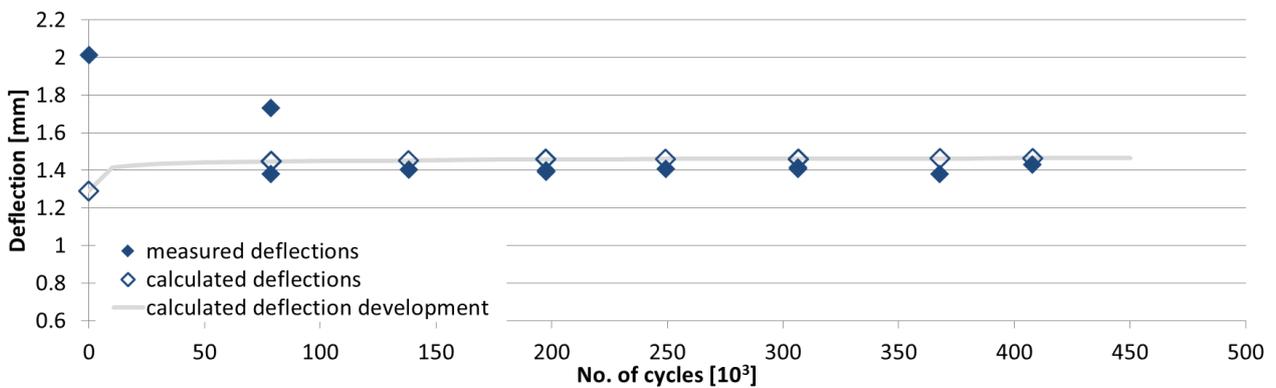
Fig. 11: Comparison of measured and calculated deflections for set #3

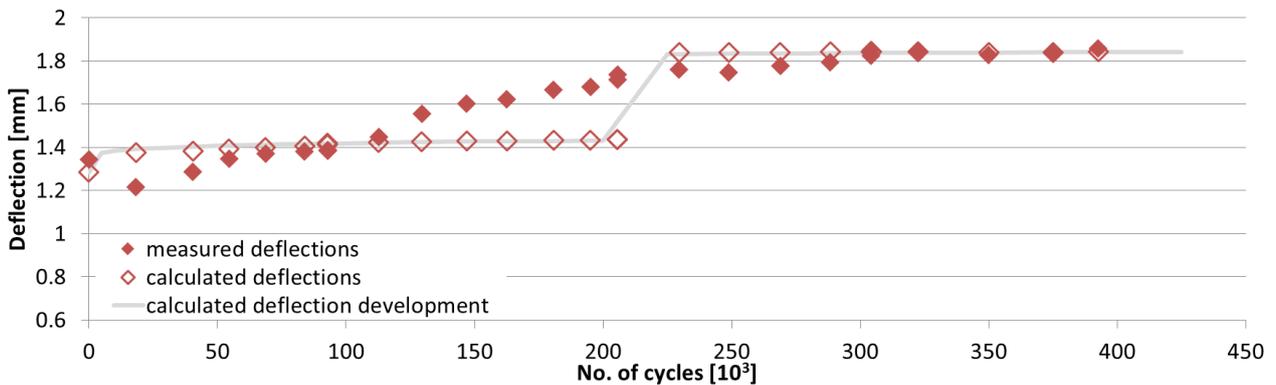
Fig. 12: Comparison of measured and calculated deflections for set #4

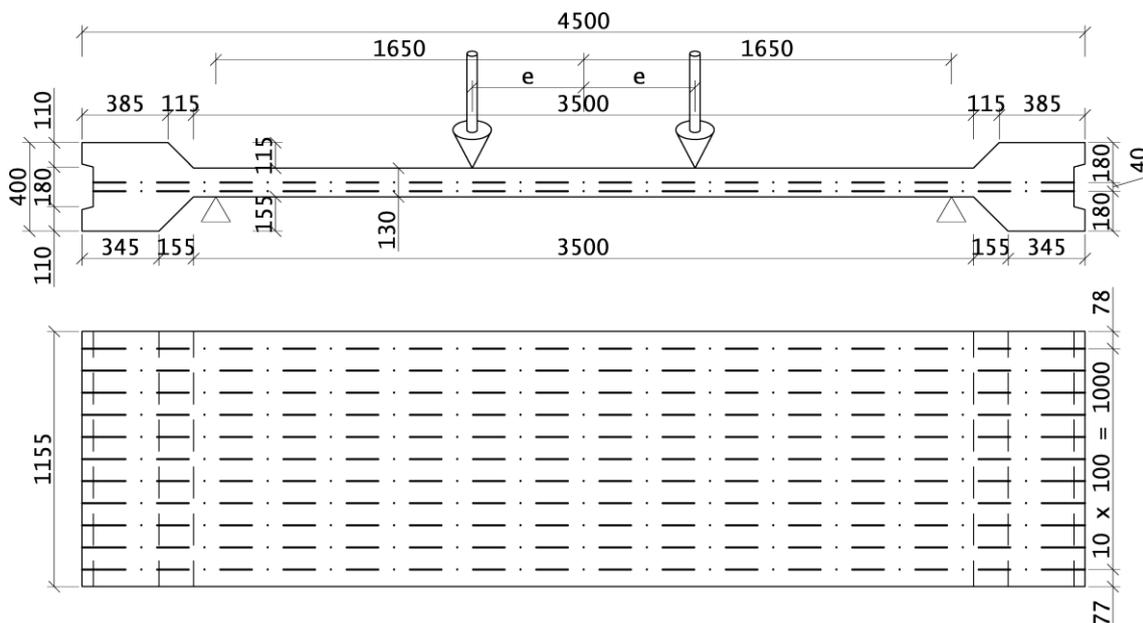
Fig. 13: Static scheme with the dimensions and the prestressing scheme in the slabs

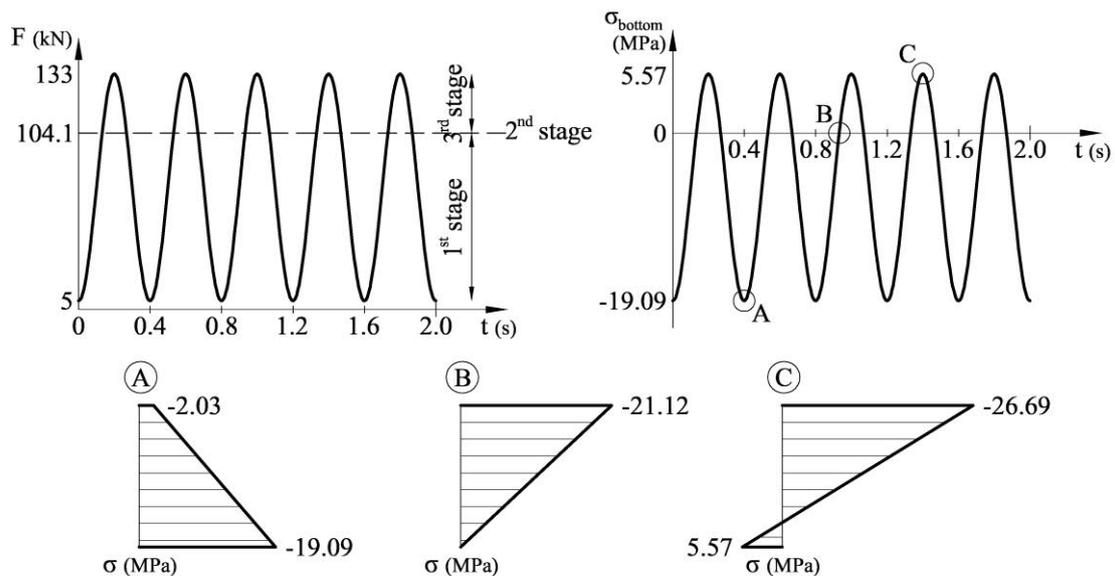
Fig. 14: Loading and stress development with emphasized stages

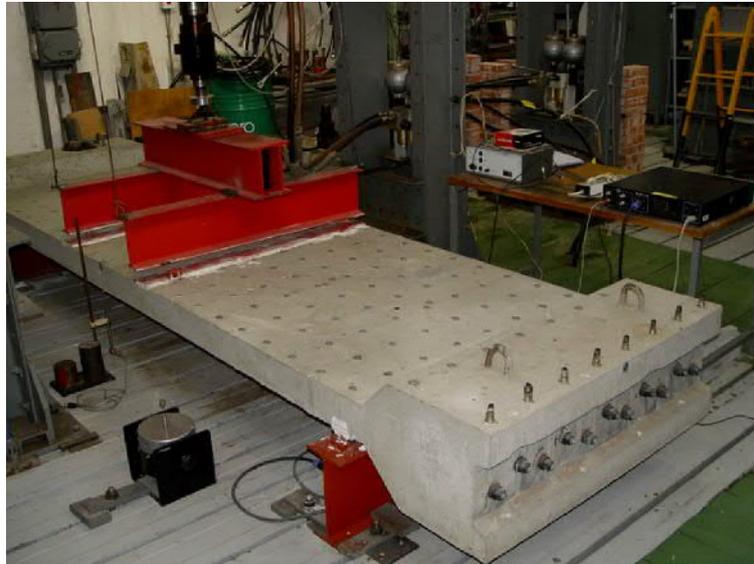
Fig. 15: Schematic layout of the experiments

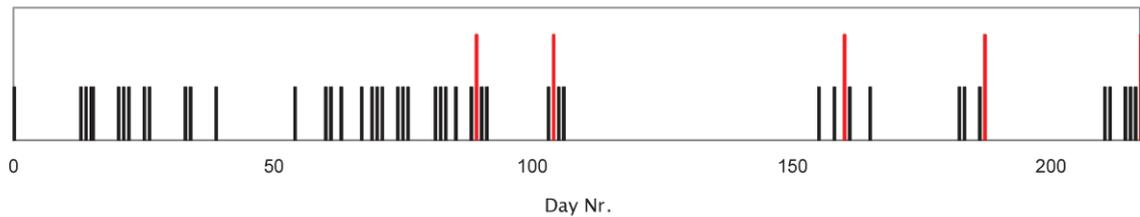
Fig. 16: Loading history of the prestressed slab with time of the deflection measurements marked

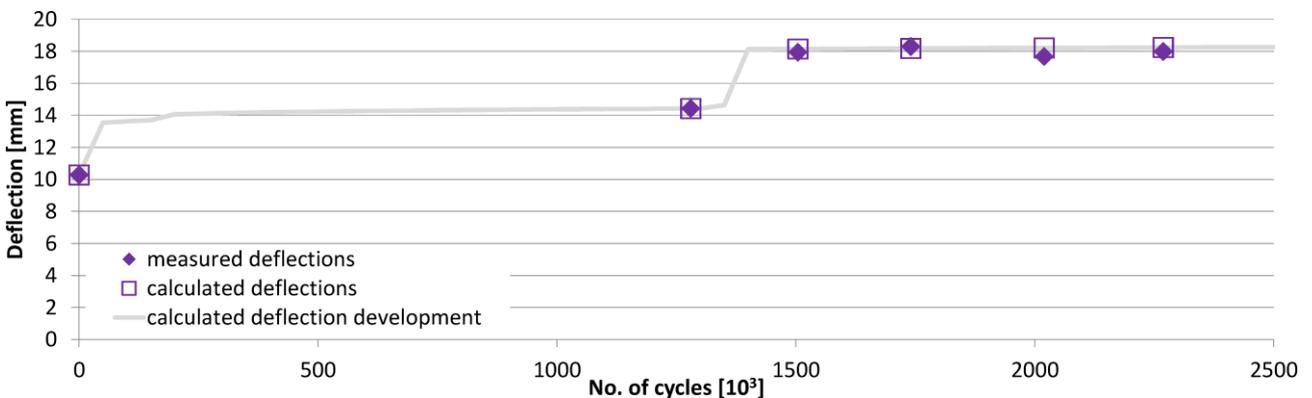
Fig. 17: Comparison of measured and calculated deflections of a prestressed specimen
