CIVIL ENGINEERING JOURNAL

číslo 3/2021

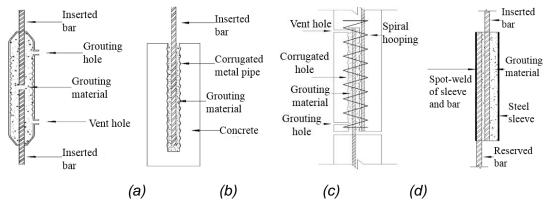
Fig. 1 - Different types of connection: (a) Grouted sleeve; (b) Grouting anchoring; (c) Corrugated pipe confined with spiral hoop; (d) Steel sleeve

Grouted sleeve connection (Figure 1 (a)) has been widely used in precast structures because of its high strength and easy implementation [19,20]. The precast components are connected by inserting the bars into the pre-embedded grouted sleeves, and then high-strength grouting material is injected into the sleeve. The typical failure type of this kind connection includes bar pull-out, bar fracture and sleeve fracture [21]. Though the grouted sleeve can effectively transfer the rebar stress, it is much more expensive than other types of connection, and its high precision and difficulty in processing have limited its widespread use [18]. Compared with grouted sleeve, grouting anchoring in a corrugated pipe (Figure 1 (b)) is much cheaper. However, the anchoring length should be considered to guarantee the mechanical performance of the connecting joint [22]. Therefore, the inserted bars are often lapped with the embedded bars, and spiral stirrup is proposed to install around the pipe to provide confinement and improve the robustness of the splices. It is strictly required that the newly formed connection joint must have a more robust performance than the longitudinal reinforcement no matter in what conditions [23], which means the corrugated pipe confined with spiral stirrup should fail later than the reinforcements it connected. Belleri and Riva [24] conducted an experimental study on the precast columns connected by corrugated steel grouting sleeve, and the results showed that this type of connection could effectively transfer steel stress. In the work of Jiang et al. [25], pull-out tests of precast concrete specimens with rebar embedded in corrugated pipe confined with spiral stirrup were carried out. The experimental results proved that this type of connection is simple, reliable and economical. Steel sleeve or metal duct grouted connector is often used in New Zealand to connect precast concrete components to their foundations [2,26]. The merit of using this type of connection is simple, but it also displayed the vulnerability, which has been revealed in several past studies [27,28]. In the work of Kim [28], the grouted metal duct connection presented a poor performance compared with cast-in-situ structure due to the pull-out of the longitudinal bar from the

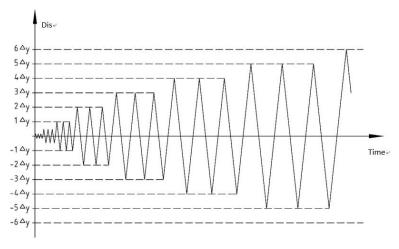
Fig. 6 - Lateral loading protocol

specimen will be termed as failed when the residual lateral load reached 80% of the peak load, and the loading process will be terminated. The lateral loading protocol is shown in Figure 6.

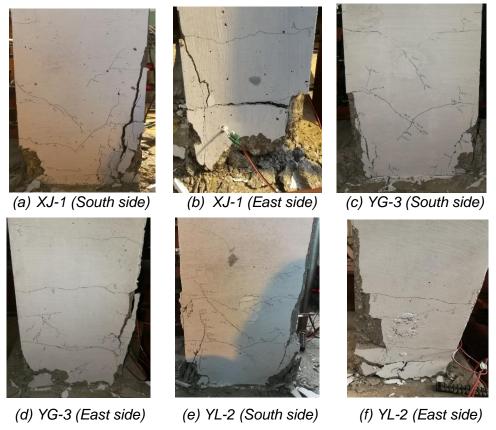
Fig. 7 - Crack patterns and failure mode of the specimens at displacement of 5Δ

As the crack kept developing at different lateral displacement, the crack patterns and failure modes were recorded when the lateral displacement reached 5Δ to compare all specimens' crack patterns and failure modes. The specimens' crack patterns and failure modes are displayed in Figure 7, where all specimens are characterized by flexural failure. Under the low-frequency reversed cyclic loading, the development and progress of all specimens' failure can be grouped into three stages: elastic stage, vielding stage and failure stage. In the elastic stage, with the development of horizontal force, the deformation of the specimen increased almost linearly, and the residual deformation was minimal. When it came to the yielding stage, the loading protocol was changed to displacement controlled. With the increase of lateral displacement, the residual deformation accumulated gradually, and more cracks occurred on all sides of the column. There began to appear crushing and spalling at the base of the column. In the failure stage, the column base had been crushed, and later quit working entirely. The crack patterns of all specimen appeared quite similar. At the beginning of loading, horizontal penetrating cracks occurred on the east and west side (the loading direction) of the column at the location where stirrups were installed, and they kept propagating and reached to the south side. Short and horizontal cracks first appeared on the south side. With the development of deformation, the short and horizontal cracks on the south side started to develop diagonally and kept propagating until they intersected at the central place of the south side in the form of "X", displayed in Figures 7 (a), (c) and (e). As the bending moment reached the maximum at the column foot; therefore, the concrete at this place reached the ultimate compressive strain and was continually crushed and peeled off. The whole failure mode of specimens is typically large-eccentric compression failure.

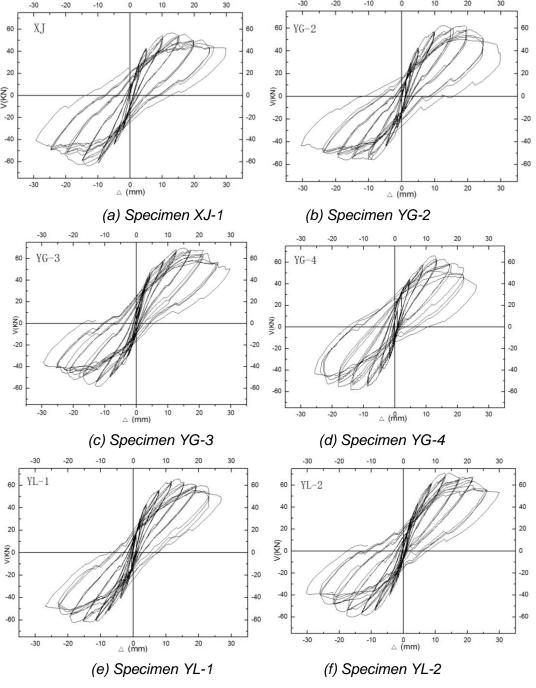
Fig. 8 - Hysteresis loops of the specimens

The hysteresis loops and skeleton curves of each specimen are illustrated in Figures 8 and 9, respectively. Hysteresis loop describes the relationship between the cyclic load and lateral displacement, reflecting the seismic performance. Figure 8 displays the development and evolution of the hysteresis loops, which are quite similar for all specimens. Under the load-controlled stage, there was no crack. Therefore, the specimens can be treated as a rigid body, and the rigidity barely changed. However, tiny and hairy cracks were produced inside the concrete, and minimal residual deformation still existed after unloading horizontal force, thus forming a tiny hysteresis loop. When it came to the displacement-controlled loading stage, concrete started to crack as it surpassed the ultimate strength. At the beginning of the displacement-controlled loading stage, although the concrete has cracked, and a small part was crushed and spalled, but it still kept working, and the stiffness of the specimens remained unchanged. In this stage, the peak horizontal load of the specimens raised with the increase of displacement, and the growth rate of peak horizontal load decreased with the improvement of displacement. At the end of the displacement-controlled loading stage, large pieces of concrete were crushed and peeled off, the stiffness declined rapidly, and the peak horizontal load decreased accordingly. Most of the hysteresis loops of the specimens are bow-shaped and have some pinching phenomenon. However, they are also fully shaped, which shows that the specimens have excellent seismic performance and ductility, and generally conform to the hysteretic curve characteristics of compression-bending members.

Compared of Figures 8 (a), (b) and (e), the hysteretic curve of the precast column YG-2 is fuller, which represents that precast column with steel sleeve connection has the similar bearing capacity, ductility and stiffness degradation with cast-in-situ column, while the seismic performance of the precast column using steel sleeve is better. After comparing the hysteretic curves of precast

column YL-1 using corrugated pipe confined with spiral stirrup with precast specimen YG-2 and cast-in-situ specimen XJ-1, the area of the hysteresis loop is smaller. Therefore, its seismic performance is worse than the other two types of specimens, though its bearing capacity is higher. The unbonded length of the three specimens displayed in Figures 8 (c), (d), and (f) are 5d, 10d and 5d, respectively. After compared with the ones without installation of unbonded treatment, the hysteretic loop of the specimens with unbonded treatment is fuller, which means using unbonded treatment could improve precast columns' seismic performance.

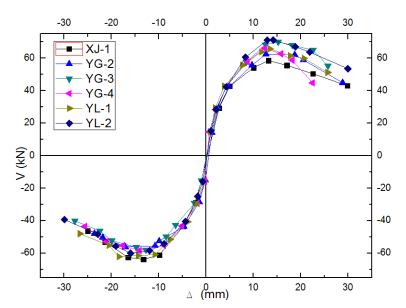
Fig. 9 - Skeleton curve of the specimens

Figure 9 shows that the increase of the horizontal force can be divided into three stages: the elastic stage, yielding stage, and failure stage. At the elastic stage, with the increase of lateral force, the precast column started to crack, and the slope of the skeleton curve began to decline gradually, which indicates that the increased speed of the lateral force slows down. When the lateral force reached the peak stage, the component reached its failure stage. After the peak stage, the lateral force decreased gradually, and more cracks occurred until the component failed finally. From the skeleton curves, it can be concluded that the cast-in-situ specimen and the precast specimens have the similar or even higher lateral resistance, which means that the proposed two types of connection are safe and reliable in connecting precast components. It also can be known that the implementation of artificially unbonded treatment helps improve the precast specimens' bearing capacity.

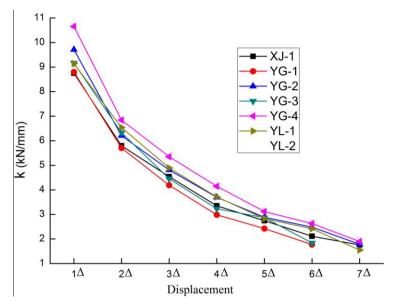
Fig. 10 - Stiffness degradation of the specimens

Where $+V_i{}^j$ and $-V_i{}^j$ is the positive and negative peak load of the i^{th} cyclic loading at the j^{th} displacement step, and $\Delta_i{}^j$ is the corresponding displacement. Figure 10 shows the stiffness degradation curve of each test specimen. It can be seen that the stiffness degraded with the increase of displacement, which all have a virtually identical decline trend, which indicates that stiffness deterioration of the two precast connection modes is similar to the cast-in-situ specimen and they both can be used to connect the precast components.

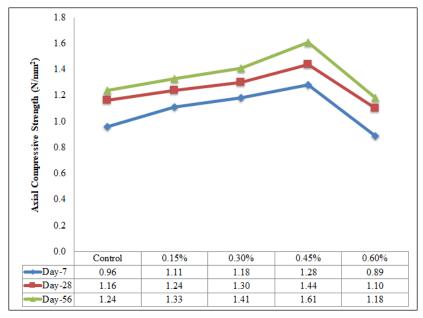
Fig. 8 - Influence of different percentages of OPPF on axial compressive strength of 600 kg/m³ density LFC

correspondingly. This shows that the addition of OPPF increases the compressive strength of LFC accordingly. There was a massive enhancement in strength from day-7 to day-90. When the OPPF volume fraction exceeds 0.45%, the compressive strength of LFC reduced intensely, as evidenced by other studies. According to Thakrele [24], the inclusion of high-volume fraction of natural fibre in LFC will impede the hydration process, consequently causing in low strength concrete. As LFC comprises void gaps of a wide range of sizes and shapes in the cement matrix and micro-cracks at the transition zone between the matrix, the inclusion of fibre can assist in the failure of the mode under compression stress [25].

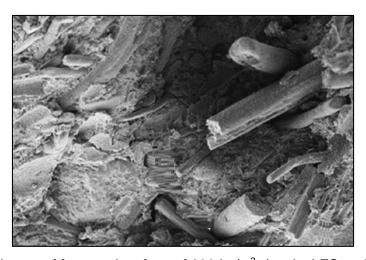
Fig. 13 - SEM image of fractured surface of 600 kg/m³ density LFC under flexural load

Figure 13 visualizes the scanning electron microscopy result of fractured surface of LFC strengthened with OPPF under flexural load. As far as flexural load is concern, there was very little indication of OPPF retreat occurred signifying the stress which was transferred to the OPPF in the cementitious composite was stronger resulting in OPPF rupture rather than principally fibre pull-out.

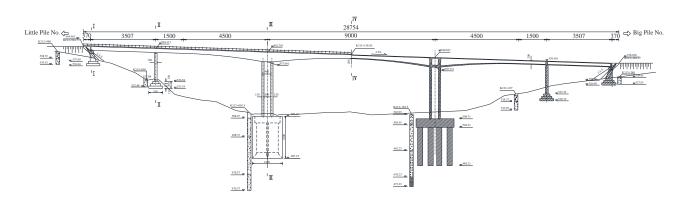
Fig. 1 – Lateral view of the bridge (unit: cm)

The span of the bridge is 35 m+60 m+90 m+60 m+35 m, and the width combination is 0.75 m+10.5 m+0.75 m. The box girder is prestressed in longitudinal, horizontal and vertical directions, and the tensioning stress is 1290 MPa. Lateral view of the bridge is shown in Figure 1 and Figure

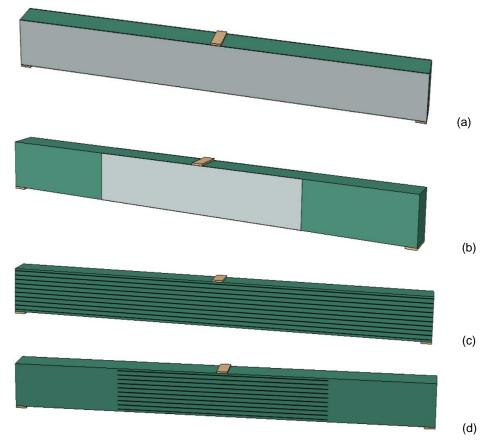
Fig. 4 — Different simulation cases applied to the retrofitted beams: (a) EBR method applied along the full span of the beam; (b) EBR method applied along half the beam span; (c) NSM method applied along the full span of the beam; and (d) NSM method applied along half the beam span

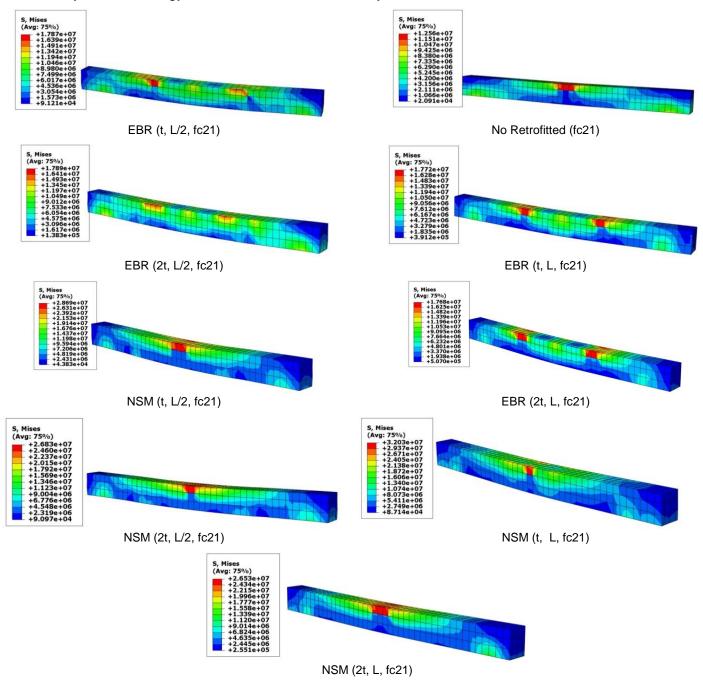
Fig. 7 – Stresses developed in the studied beams in different cases

Figures .7 and 8 show the stress characteristics as well as the load-displacement diagrams obtained from the present simulation and finite element analysis of the models generated for the studied beams. The diagrams express stress, displacement, and force in kPa (kN/m2), m, and kN, respectively. When CFRP sheets coat on the surface of the beam, the beam's ability to prevent cracking and crack spreading and the flexural strength of the beam increased. In this situation, the combination of normal and shear stresses makes the von Mises stress criterion more prominent, while the NSM method is not considered crack propagation. The other concept considered in this study was the energy absorbed in different cases by the studied beams.

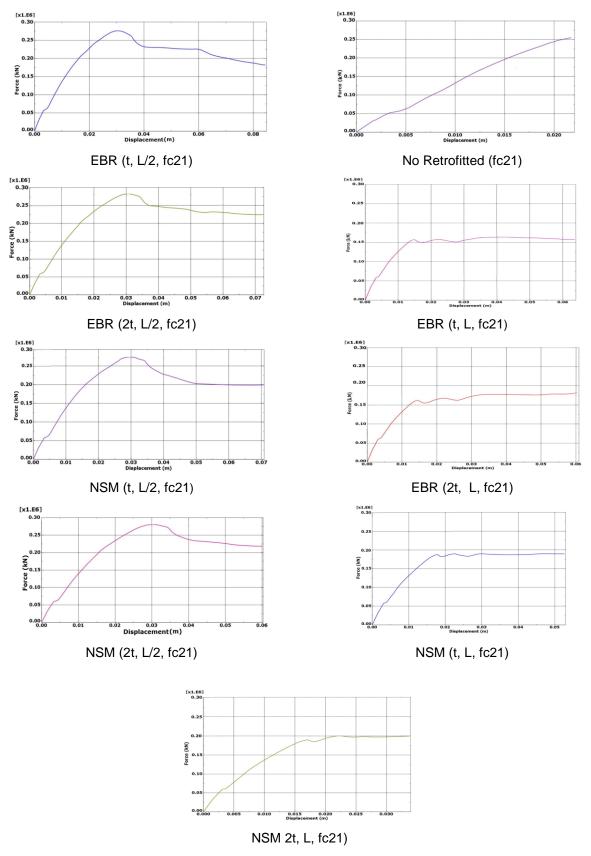
Fig. 8 – Load–displacement diagrams obtained for the studied beams in different cases

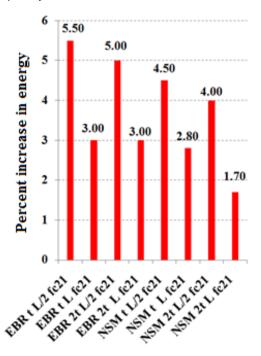
Fig. 13— Comparison of energy absorption ratios in different cases, demonstrating the respective effects of the employed retrofitting methods

Figure 13 compares the increase in the energy absorption capacity in different cases to determine the impact of the retrofitting method on the results. As evident from the figure, the energy absorption capacity increase in most studied beams retrofitted by the EBR method was greater than that obtained by the NSM method, amounting to more than 76% in the case abbreviated as EBR 2t L fc21MPa. This can be attributed to the fact that, when the entire length of the beam is retrofitted with CFRP sheets, crack formation and propagation in the beam will be better prevented, further increasing the load-bearing capacity.

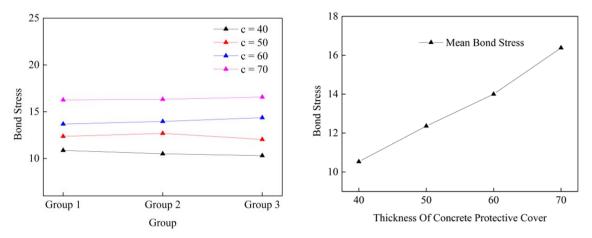
Fig. 11 - Bond stress under each protective layer thickness Fig. 12 - Average bond stress

The thicker the protective layer is, the greater the constraint effect on splitting will be. For PUC specimens, the increase in the thickness of the protective layer can limit the propagation of splitting cracks, or even prevent the occurrence of cracks, but this restriction is not infinite. It can be seen from the figure that the bond strength increases with the increase of the thickness of the protective layer. When the thickness of the protective layer is 40 mm, the average bond stress is 10.53 MPa. When the thickness of the protective layer is C50, the average bond stress is 12.36 MPa, which increases by 17.38% compared with that of 40 mm. When the thickness of the protective layer is 60, the average bond stress is 14.00 MPa, which increases by 13.27% compared with that of 50mm. When the thickness of the protective layer is 70 mm, the average bond stress is 16.38 MPa, which increases by 17.00% compared with that of 60 mm.

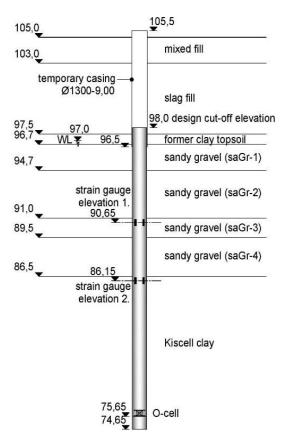
Fig. 1 – Stratification

The Kiscell clay appears in the depth of 18.5 m under the surface. It must be noted, however, that this depth is only valid in the vicinity of the borehole near the test pile, the clay surface related to the entire area shows an inclination moving away from the Danube. On the basis of the plasticity index ($I_p = 15 - 25\%$) the clay can be regarded as low-medium plasticity clay. Resulting from its low water content (w < 10%) and high consistency index ($I_c = 1.4 - 1.5$), it can be classified as hard. According to tests related to permeability ($k = (3 \div 5) \cdot 10^{-12}$ m/s), it can be regarded as watertight. Figure 2. presents the soil samples of the Kiscell clay taken at depth of ~20 m.

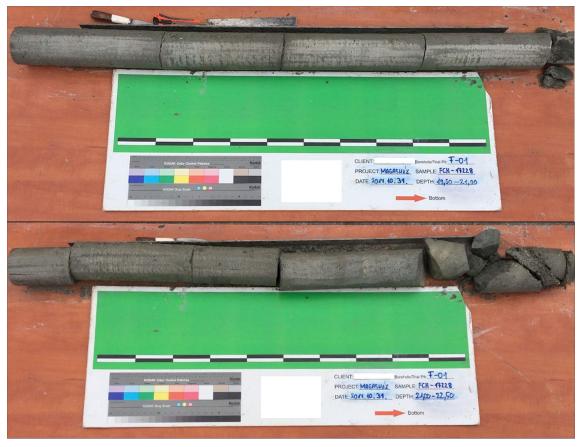
Fig. 2 – Core samples from the top zone of the Kiscell clay layer

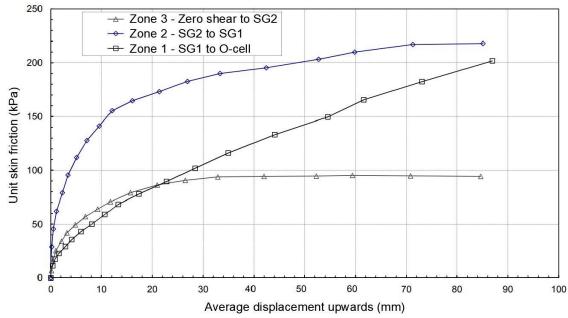
Fig. 3 – Mobilized specific shaft resistances

The resistance of the top part is provided by the skin friction. For the determination of the net load acting upon the pile from the load operated by the cell for the top section the counterforce shall be deducted, the value of which is 0.36 MN. Ignoring the last three load steps due to the above-mentioned reasons, the displacement of the top section was 55.97 mm due to the 12.34 MN force (11.98 MN net load). It is worth taking into consideration the measurement data describing the relationship between the force and the displacement for the modeling up to this point as the unconsolidated displacements measured in the last three steps are probably smaller than the actual ones.

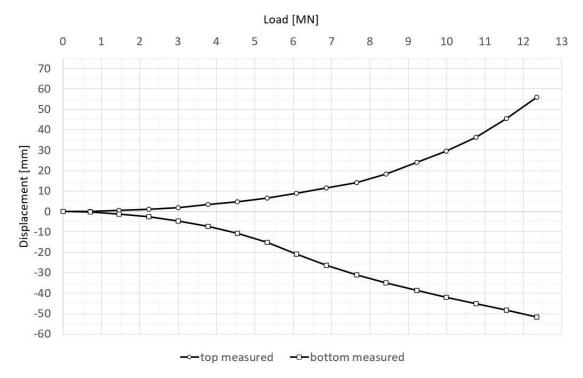
Fig. 4 – Load test curves of top and bottom parts

an inflexion point at the load that belongs to it a certain degree of stiffening might be experienced for greater forces. The displacements do increase due to the increasing load but at a slightly smaller rate than before. This is a contrary behavior to what is common. No direct explanation can be traced in the measurement data, however, the displacement gauges of the O-cell and the strain gauges both indicated some anomaly, which might refer to uneven force transfer and eccentricity. (It might also arise that the initial greater displacements derive from the compression of the soil that was slightly loosened at the base of the boring and of the settled slurry.) Certainly, the modeling of the inflexion curve could not have been the aim, only the approximation of the curve with the least deviation.

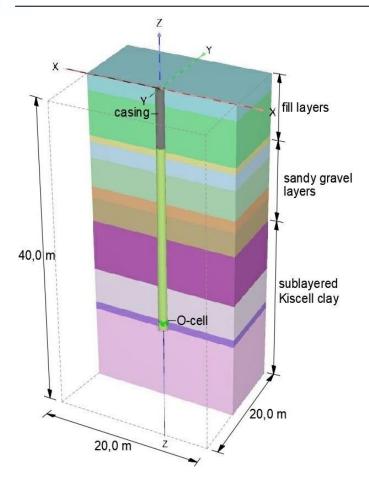
Fig. 5 – Model of O-cell pile load test

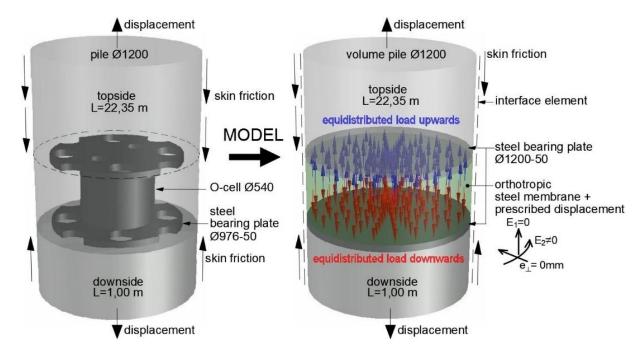
Fig. 6 – Model of O-cell

to follow the opening-closing axial movement of the O-cell. However, for radial forces on the pile axis it behaves stiffly, supporting the neighboring soil elements.

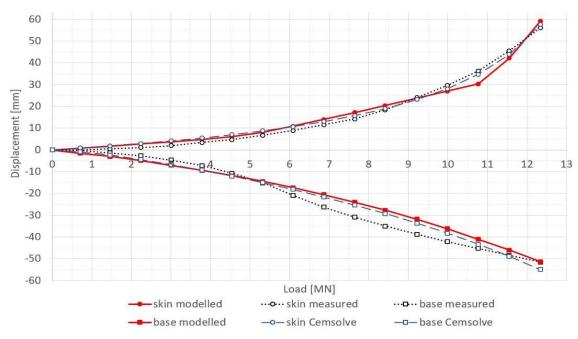
Fig. 7 – Modeled and measured load-displacement curves

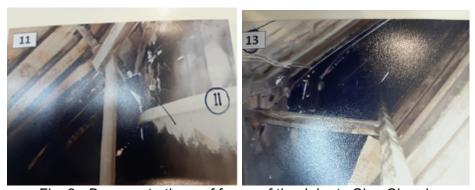
Fig. 2 - Damage to the roof frame of the Jakarta Sion Church.

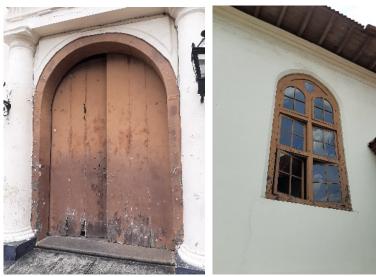
Fig. 3 - Door and window of the Jakarta Sion Church

and sunshine. It indicates that the doors and windows of the Sion Church should be replaced with better wood materials and make a canopy to protect them from rain and sunshine.

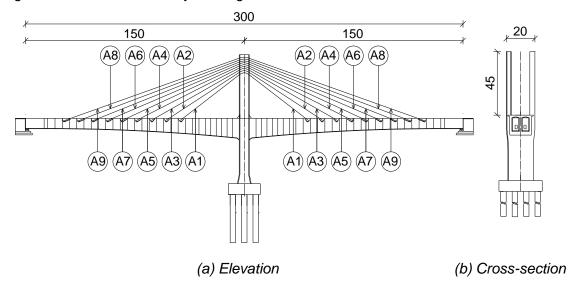
Fig. 1 – Schematic diagram of cable-stayed bridge layout (unit: m)

In this paper, the overall finite element model of cable-stayed bridge was established with the Midas/Civil software, and the local solid model of the tower-beam-pier joint zone of the cable-stayed bridge was established by using ABAQUS software. The accuracy of the local solid model was verified by comparison of the results, and on this basis, the stress comparison analysis of the tower-beam-pier joint zone with different anchorage forms was carried out. The influence of anchoring on the force of cable-stayed bridge was discussed.

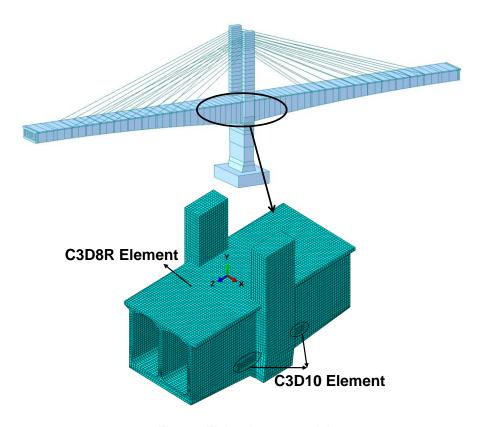
Fig. 2 - Finite element model

The finite element software ABAQUS was used to establish the local model of the tower-beam-pier joint zone of the cable-stayed bridge, as shown in Figure 2. The submodel method was adopted [14], and the whole model provided boundary conditions for the local model. To avoid the influence of boundary conditions on force of the joint zone, enough length of the main girder should be cut off. In the local model, the transverse bridge direction was the full width of the main beam, which was symmetrical along the bridge direction to the middle line of the bridge. The local corner of the chamfering section of the box girder at the end of the beam was C3D10 element, and the rest section was C3D8R element. There were 76007 elements in the model. Midas/Civil was used to establish finite element rod system model of the full bridge, and length of the intercepted main beam in tower beam pier joint zone was 31 m, as shown in Figure 3. There were 228 nodes and 188 cells in the model.

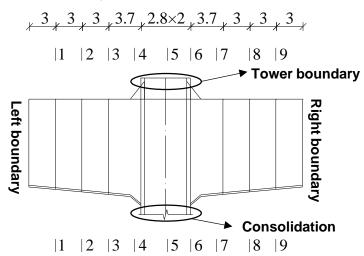
Fig. 3 – Schematic Diagram of Control Section (Unit: m)

In the actual situation, various working conditions need to be considered about the stress of the bridge. In this paper, internal force combination under maximum cantilever during construction stage was analyzed, and stress distribution and transfer law in the joint zone were studied. The internal forces applied to the boundary were shown in Tab. 1.

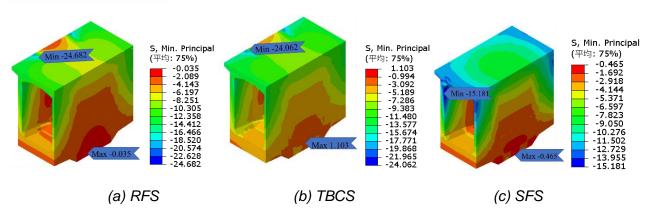
Fig. 7 - Cloud diagram of the third principal stress

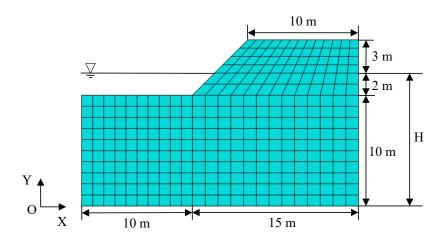
Fig. 2 – Finite element mesh model

The mathematical model established in this section is an ideal slope. The slope angle is 45° and the slope height is 5 m. The initial groundwater level is 2 m above the foot of the slope, and the foundation size is 10 m. Based on the above theoretical analysis, the finite element model was established in ABAQUS and shown in Figure 2.

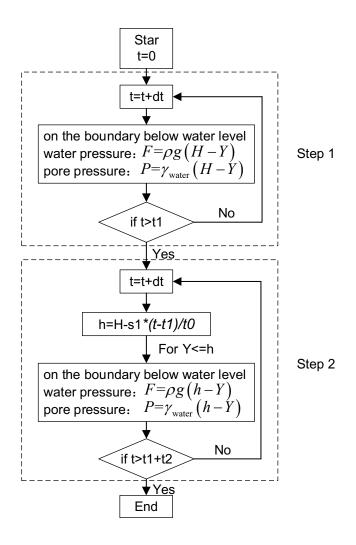
Fig. 3 -Calculation flow chart

When there is a rainstorm or other special circumstances, the water level of the channel will change suddenly in a short time. In ABAQUS, there is no function to directly set the sudden change of water level. In order to further analyse and study the canal segment performance in the case of sudden change of water level, it needs to be realized through secondary development. This research is implemented by FORTRAN program. The calculation flow chart is shown in Figure 3, where Y is the height value of node on the boundary below water level, ρ is the density of water, $\gamma_{\rm water}$ is the bulk density of water, t1 is the time of Step 1, t2 is the time of Step 2, s1 is the water level that decreases in time t0. It is assumed that the water level will drop by 2 m within 24 hours as an example.

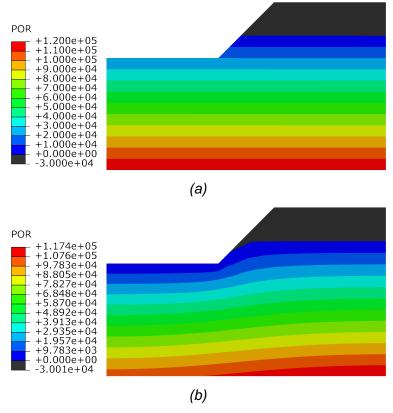
Fig. 4— The pore pressure nephogram: (a) before sudden change of water level; (b) after sudden change of water level

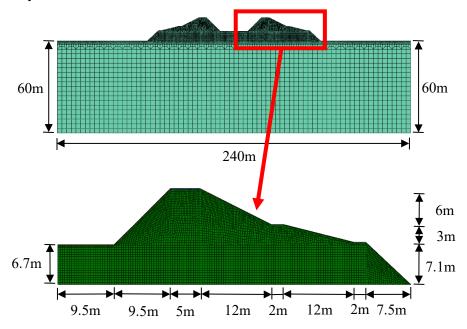
Fig. 6 – The finite element model of high fill canal segment

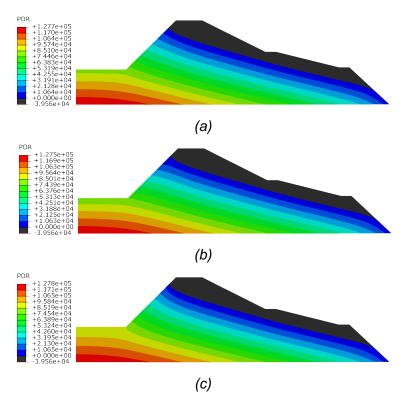
Fig. 8 – The pore pressure nephogram of high fill canal segment: (a) normal; (b) case 1; (c) case 2

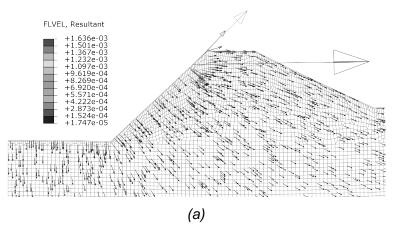
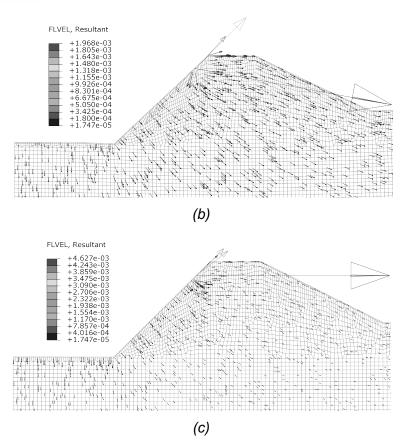
Fig. 9 – The velocity vector diagram of grid integration point of high fill canal segment: (a) normal; (b) case 1; (c) case 2

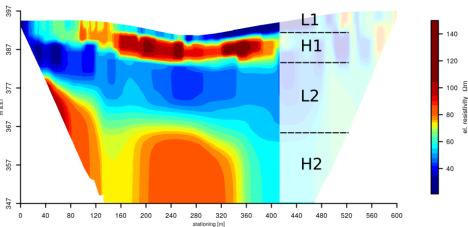
Fig. 9 - The profile TFC5 with clearly developed 4 distinct subsurface layers. Similar stratification is to some extend visible at all measured ERT transects. The TFC5 transect is used here as an example.
